Flawed Logic: The Hyundai Anti-Theft Campaign

An analysis of the campaigns to address rampant theft
of Hyundai and Kia vehicles across America

FULL REPORT – DEFECTS & ANTI-THEFT CLAIMS

Rev. 1/22/2026

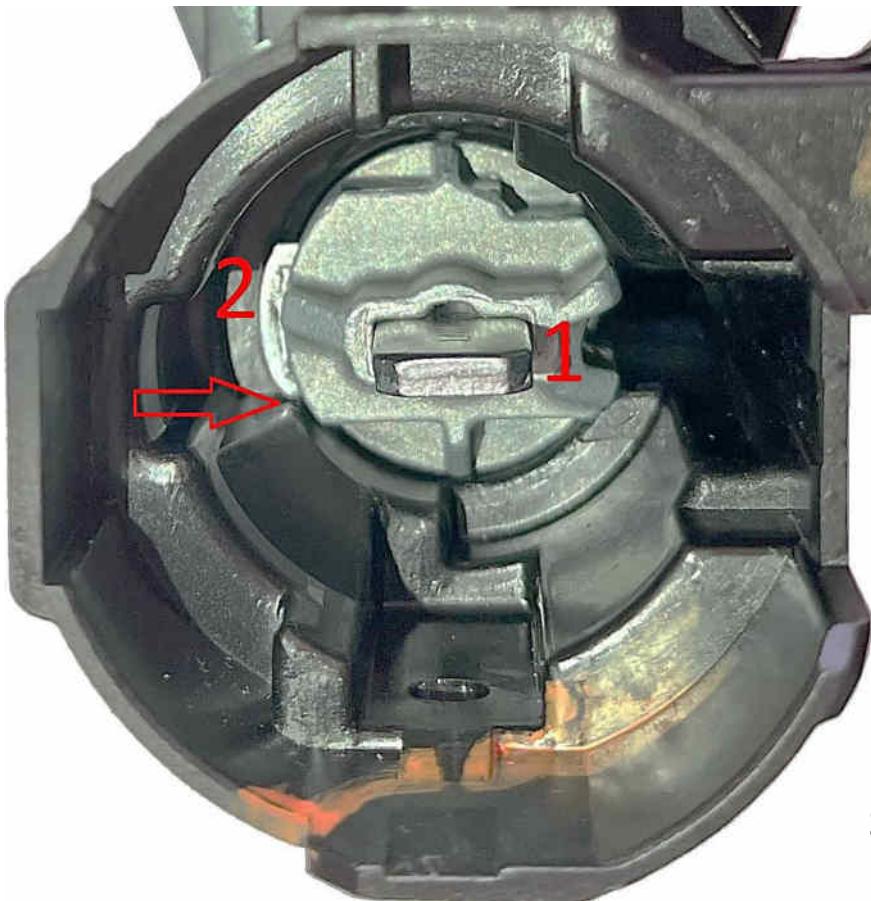
2015 Hyundai Elantra

Defect: The tab's edge (ARROW) makes approximately 1 mm of contact with the plastic housing, which over time carves and deforms the plastic, creating a small channel or ramp. This design flaw has resulted in millions of defective ignition assemblies in which the tumbler-rod's tab can retract on its own, allowing the cylinder to turn to LOCK without the key being pushed into the cylinder.

As a result, this critical safety mechanism is circumvented. The plastic ignition assembly lacks adequate reinforcement, rendering the push-to-lock mechanism defective and unreliable.

AutoSafe contends that this defect within the affected ignition assemblies concerns an important safety feature that should be recalled. We suggest replacement with a metal reinforced housing.

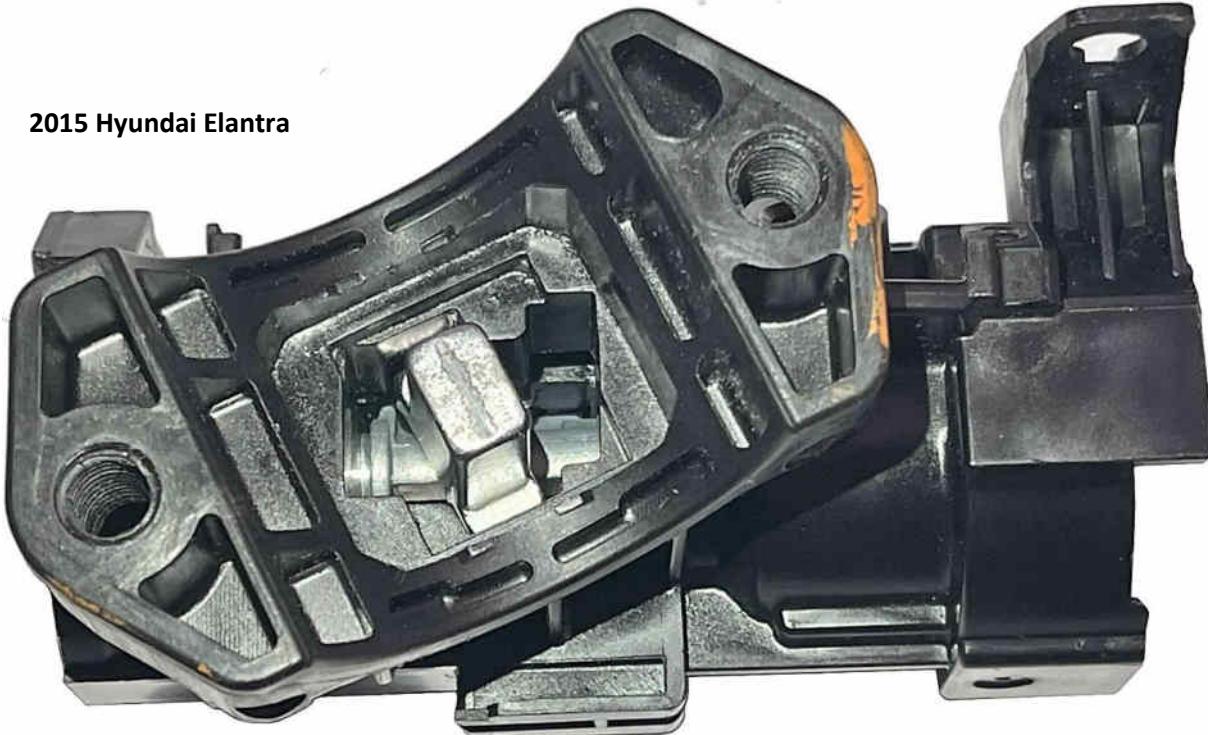
2015 Hyundai Elantra

However, the contact surface between the tumbler-rod catch and the lock-bolt assembly is minimal—limited to roughly 1 mm at an angled edge. Because both parts feature rounded edges and a sloped profile, the catch can slip past the lock-bolt's edge under certain conditions, creating the potential for a steering-lock malfunction.

Paint transfer between tumbler-rod and lock-bolt.

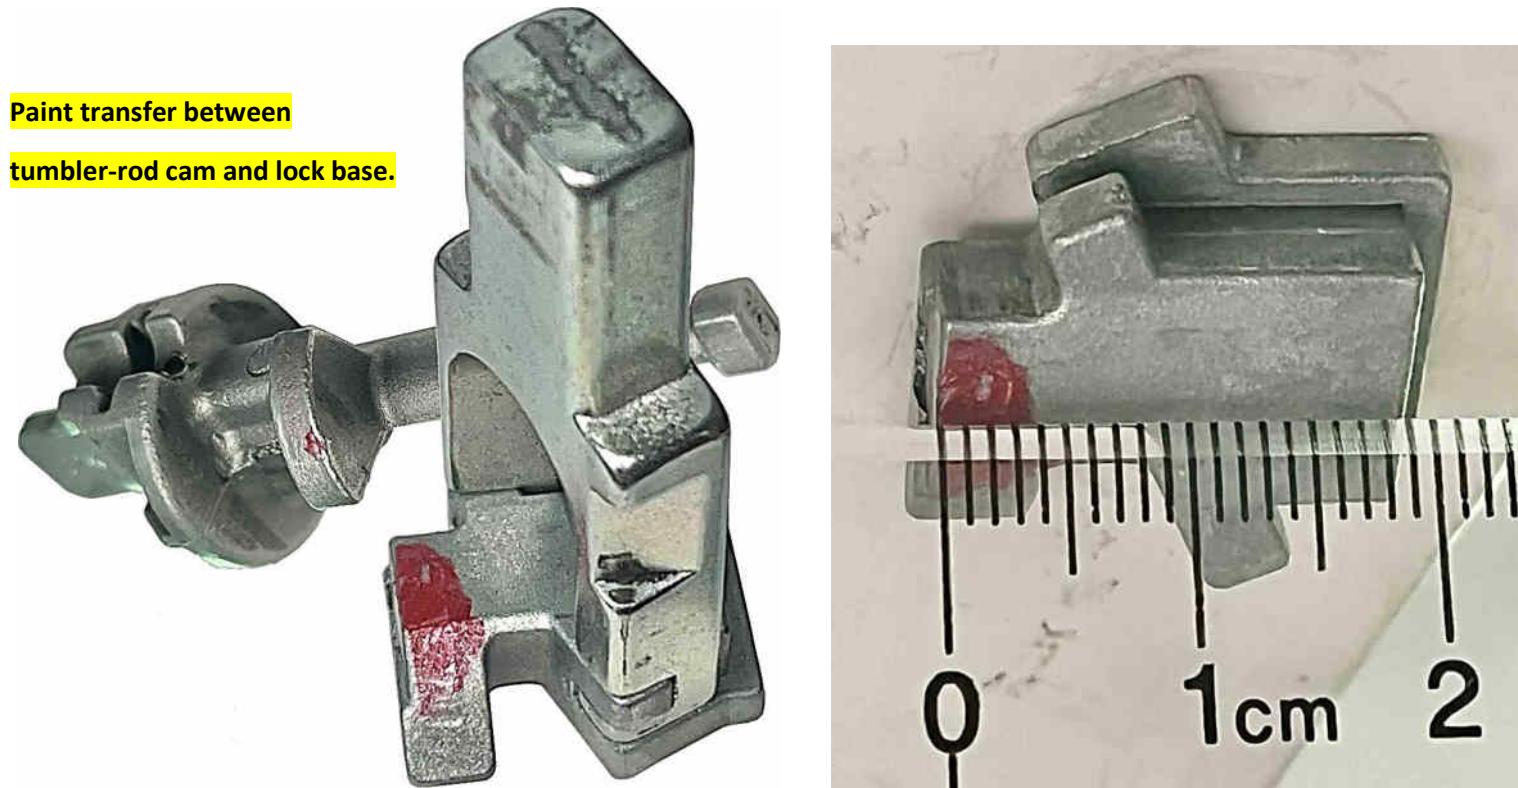
The tumbler-rod's cam makes as little as 2 mm of contact with the base of the steering-lock assembly. The tumbler-rod itself has approximately 1 mm of lateral tolerance, resulting in a contact range of 2–3 mm between the cam and the base.

If the tumbler-rod moves laterally by as little as 2 mm while in the ON position, it can slip off the lock's base, causing the lock-bolt to spring up and resulting in a steering lock-up malfunction.

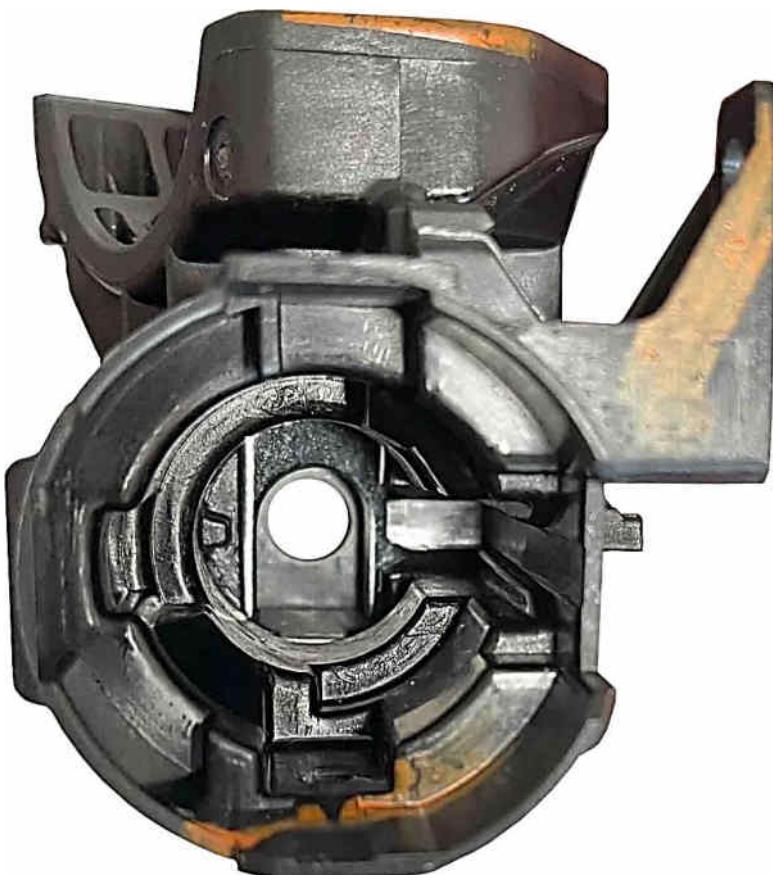
2011-16 Elantra Housing

Below, we compare the 2011–2016 Elantra ignition assembly (left) with a later-generation Hyundai housing. In the updated design, a raised stop-channel (circled in red) has been added to the assembly housing—an important feature absent from the 2011–2016 design.

Note: To determine whether Hyundai had retroactively corrected this issue, we purchased a replacement ignition assembly for the 2011–2016 Elantra. Disappointingly, these assemblies continue to be sold without the stop-channel, leaving the vulnerability to lateral movement unresolved.

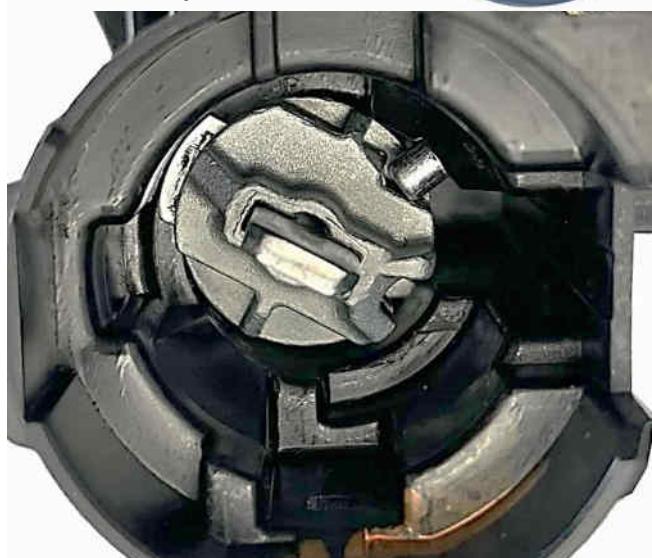
Steering lock malfunction in ON position.

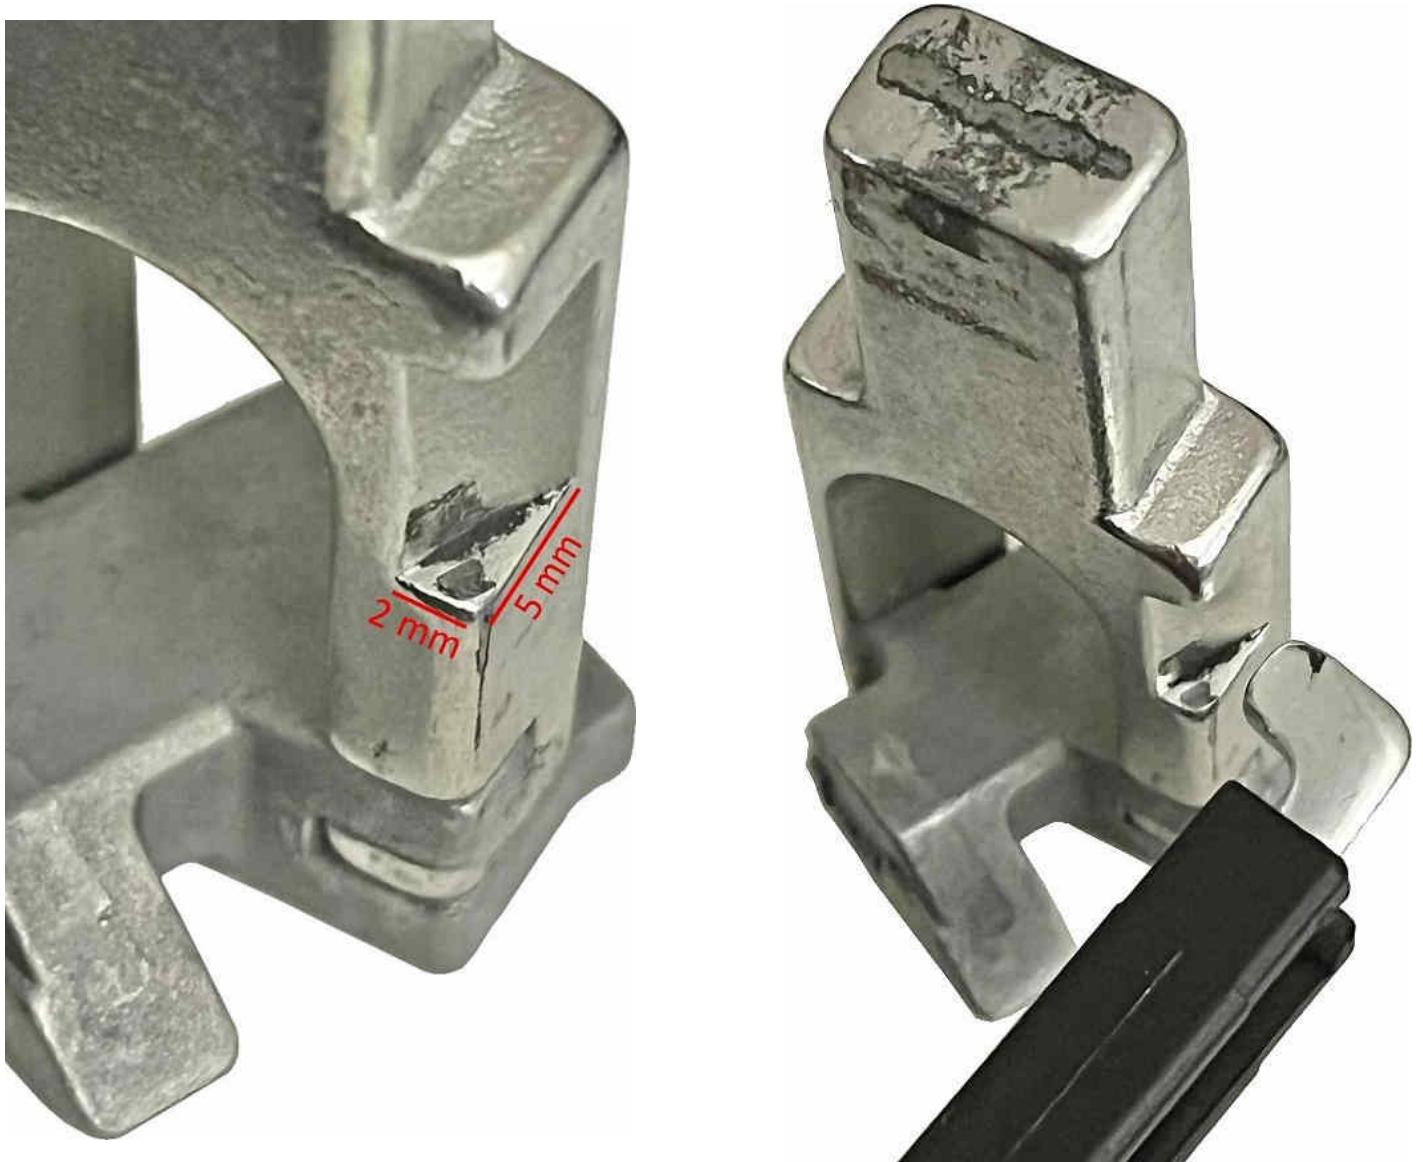
Lever Latch – Substandard Construction (Rounded / sloped edges)

In the 2011–2016 Elantra, we observed that the side of the lever contacting the lock is noticeably more rounded and sloped compared to the opposite side. Additionally, the entire lever exhibits more play than the lever used in older-generation Elantras. The combination of the sloped edge and increased play further reduces the effective surface contact between the lever and the lock's notch, thereby decreasing the overall effectiveness and reliability of the mechanism.

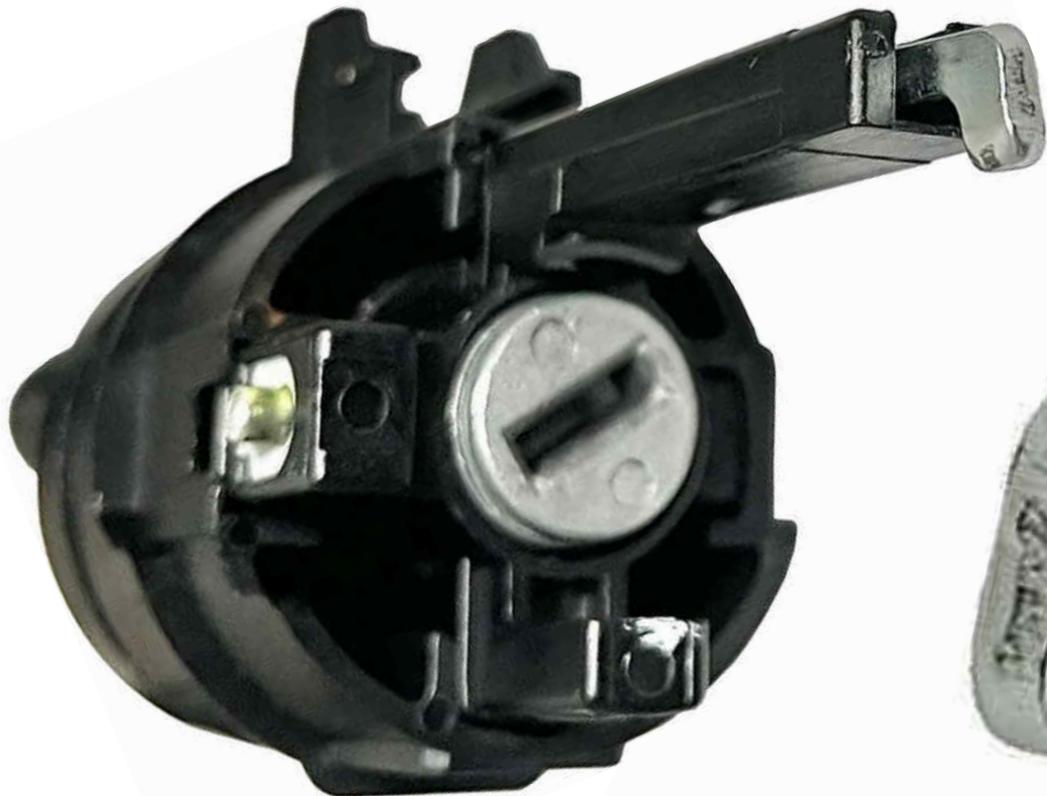
2011-2016 Elantra lever

We compared the lever from a 2015 Hyundai Elantra (2011–2016 model) to a lever from a 2008 Elantra (2007–2010 model). The 2015 lever has a noticeably rounded edge and significantly more play, whereas the 2008 lever features a well-defined edge with minimal movement. This contrast highlights the reduction in effective contact and reliability of the later mechanism.

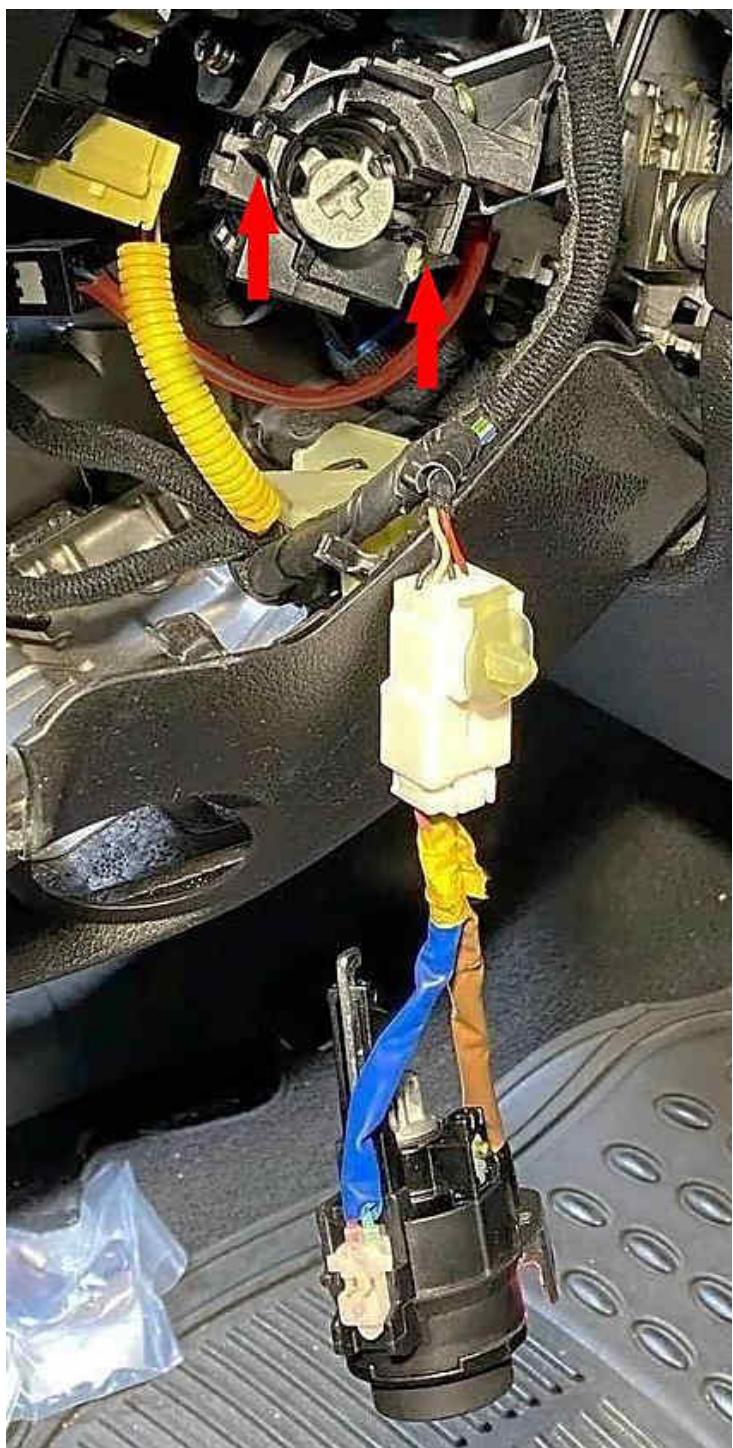
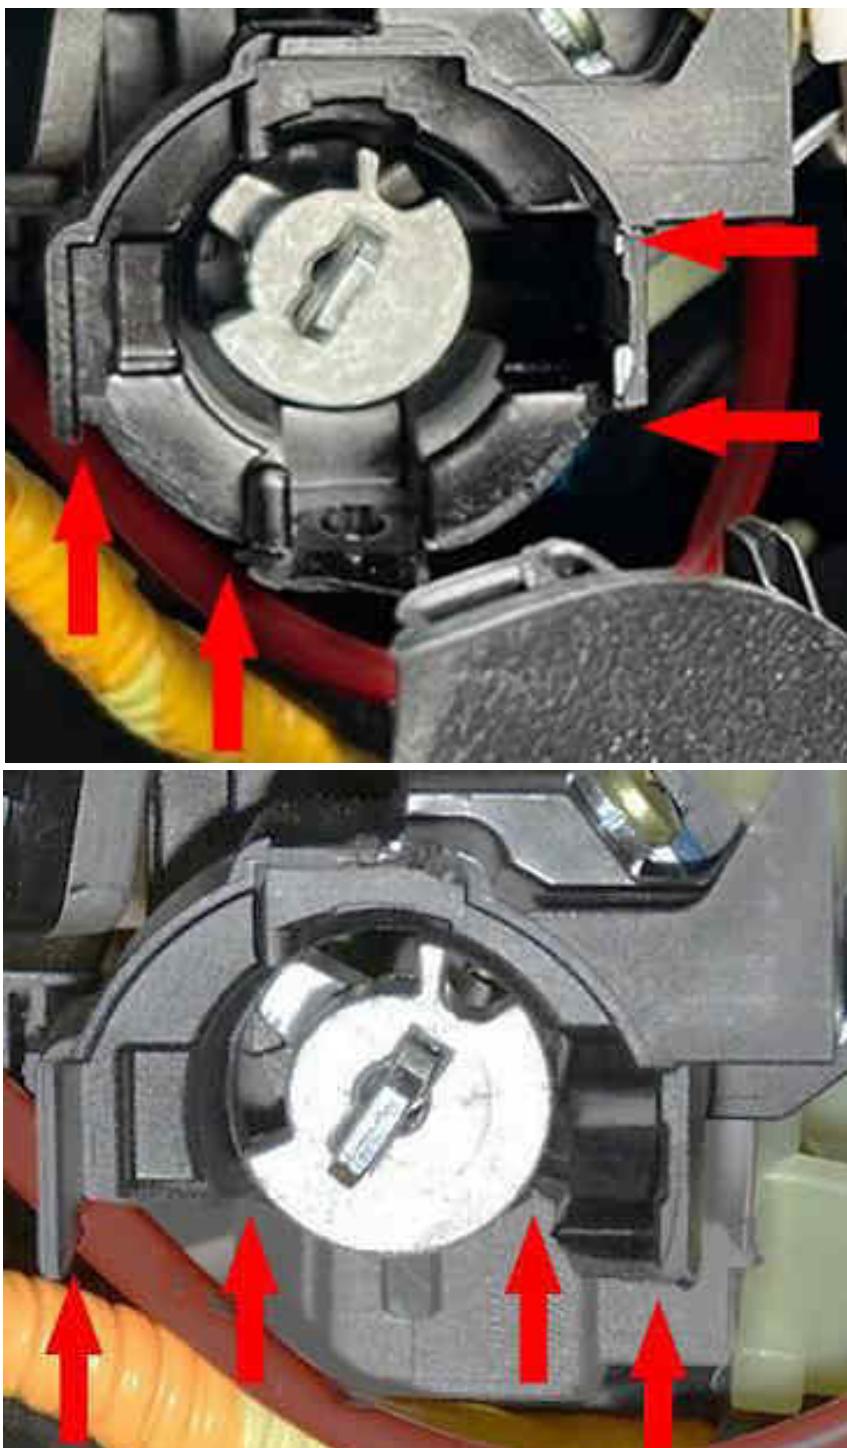
Photo of ignition assembly housings documenting theft damage. Tumbler-rod in OFF/LOCK position. Red arrows are noting areas of either cracked or missing plastic.

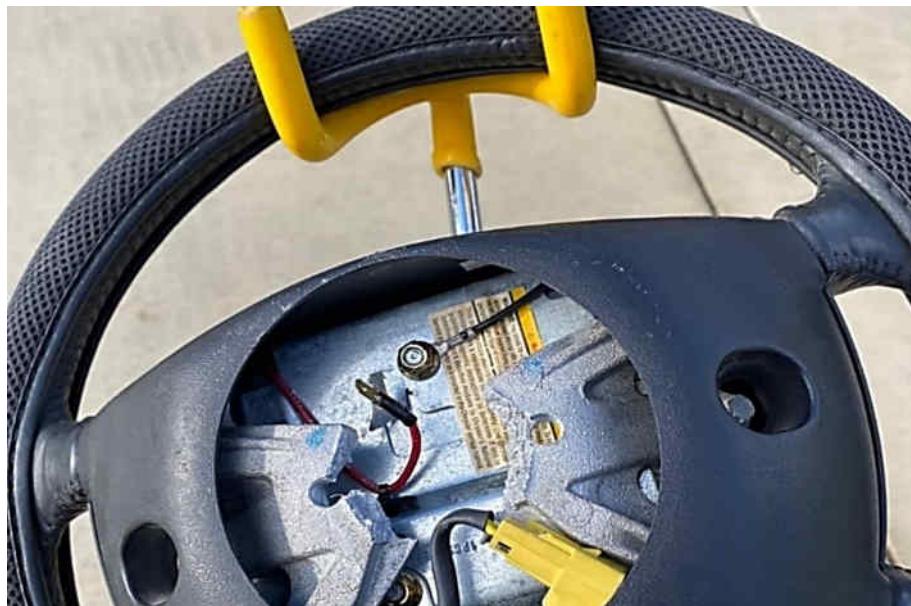
The picture below shows a real-world example of the torque and strain sustained by a steering wheel (and by extension, the steering column and ignition assembly) when thieves attempted to forcefully remove a steering-wheel lock.

Note how the steering wheel's metal bracket was sheared by the force applied through the steering-wheel lock.

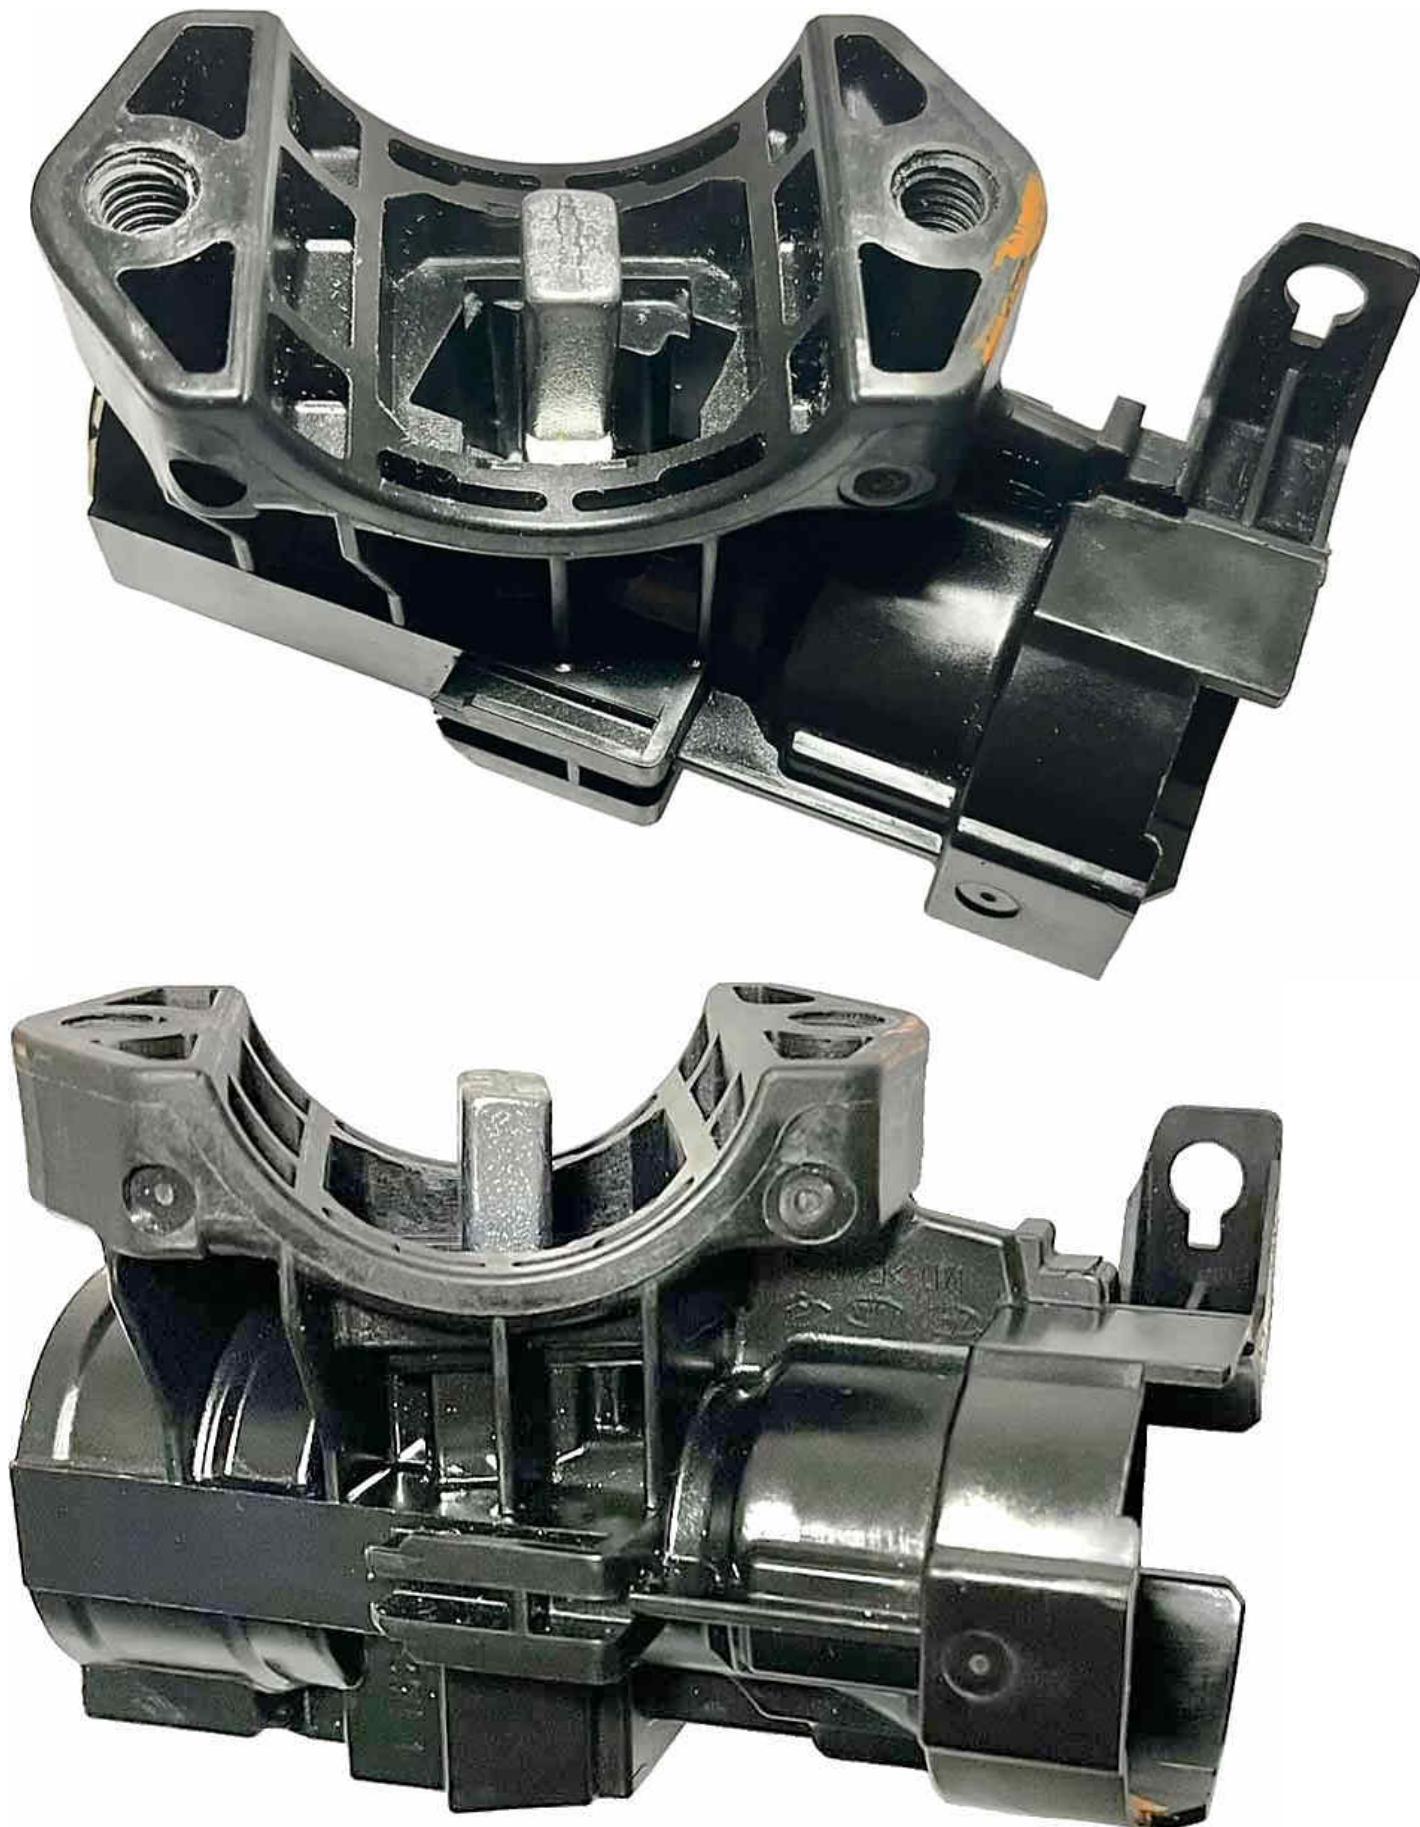
The ignition assembly's plastic housing was not engineered to withstand the extreme stresses produced by Hyundai's steering-wheel lock mechanism. Instead, it was manufactured with hollow crevices to reduce plastic use and lower costs. The wall thickness around the steering lock varies but averages approximately 2 mm.

It is evident that the torque transmitted through the steering column and onto the ignition assembly's steering lock imposes extreme stress on the fragile plastic housing. This excessive stress can cause deformation and/or stress fractures within the housing's thin plastic walls.

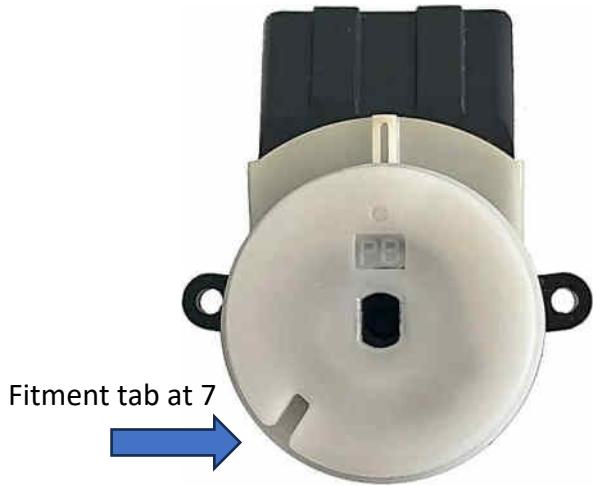
2011-2020 ignition switch ("PB")

We believe Hyundai has also identified the 2011-20 ignition switch as a potential hazard and cause for such malfunctions due to its low turning resistance. We observed that the 2021+ Hyundai Elantra uses what appears to be a new ignition switch model, which can be visually distinguished by its black plastic shell cover instead of the previous 2011-2020 ignition switch's white shell. The new black shell also changes its fitment tab (9 o'clock position) from the white shell (7 o'clock position).

AutoSafe's evaluation proposes issuing a recall for the ignition switch component within the above listed vehicles in order to replace the 2 internal soft springs with the stiffer springs that increase switching resistance.

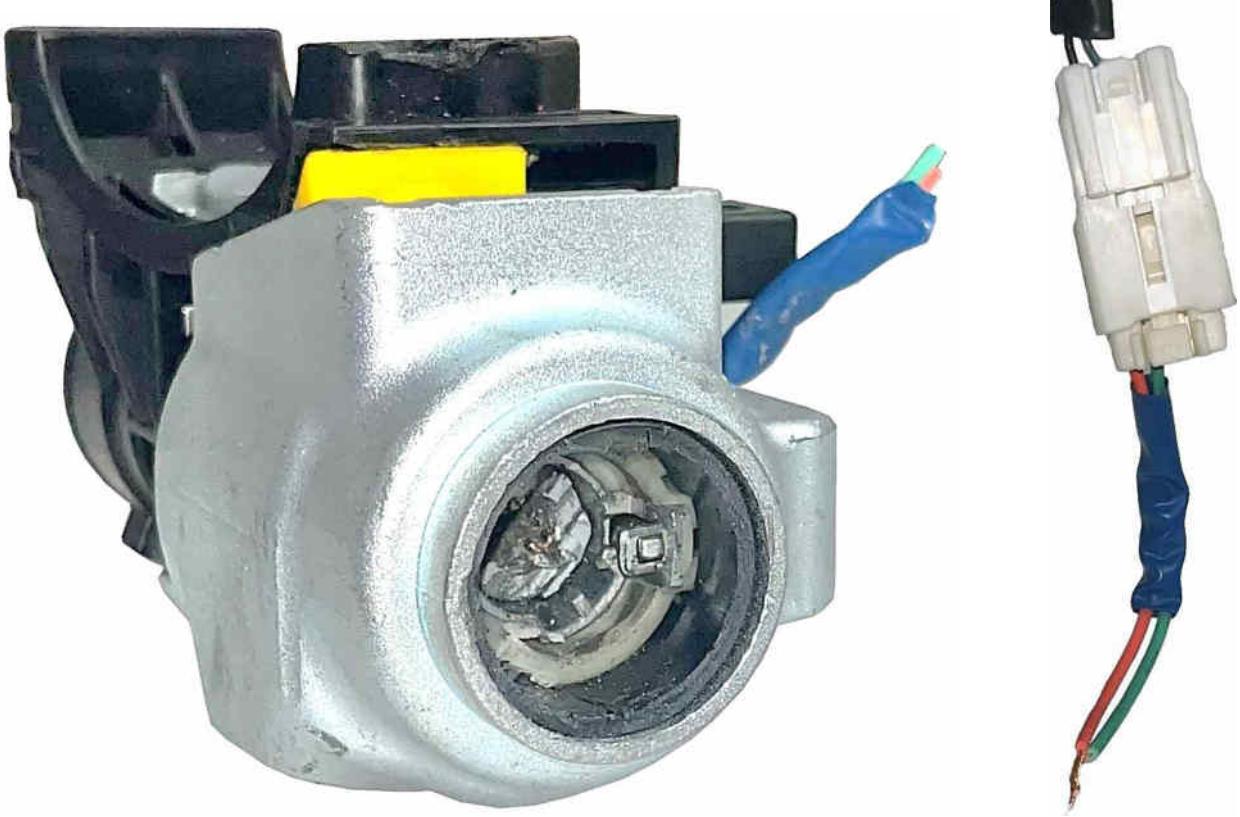
The plastic cover of the cylinder has been left uncovered and unprotected.

The uncovered plastic face of the cylinder can still be easily broken off and allow the internal components of the cylinder to be pried out and turned with a flathead screwdriver, which is made even easier with the use of vice grips or locking pliers.

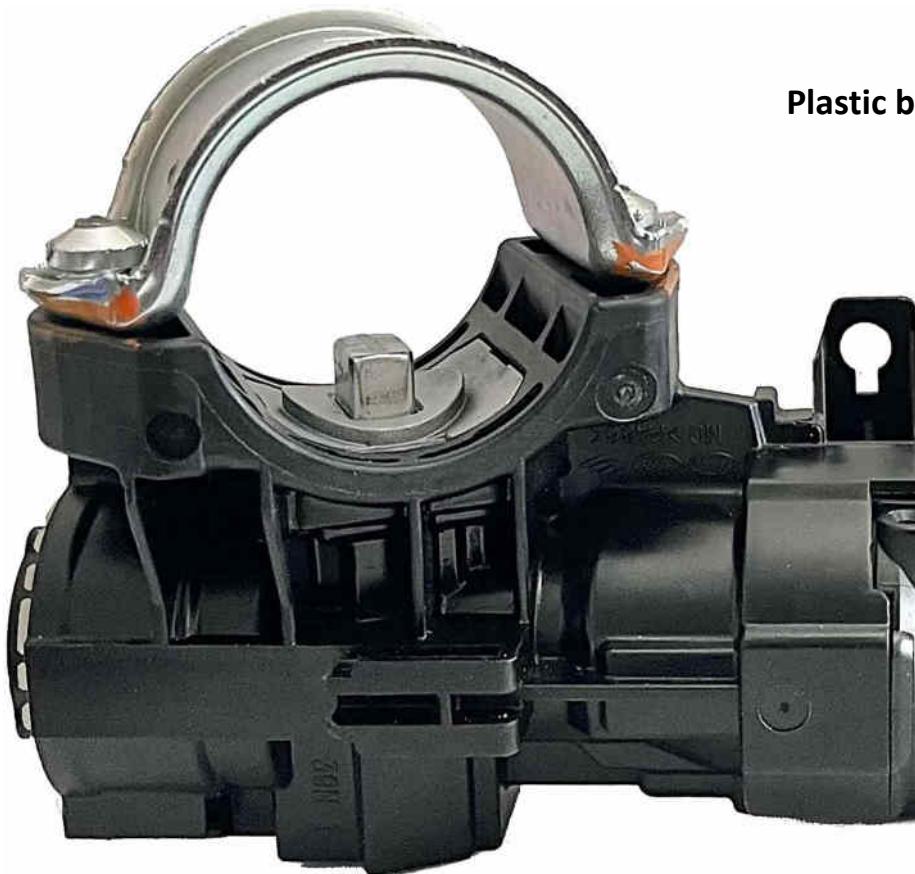
Plastic body and threads

Another issue that the cylinder sleeve fails to address is that the assembly is secured to the steering column by metal bolts, which are held in by the assembly's plastic body and threads.
