Flawed Logic: The Hyundai Anti-Theft Campaign

An analysis of the campaigns to address rampant theft
of Hyundai and Kia vehicles across America

FULL REPORT – DEFECTS & ANTI-THEFT CLAIMS

Rev. 1/22/2026

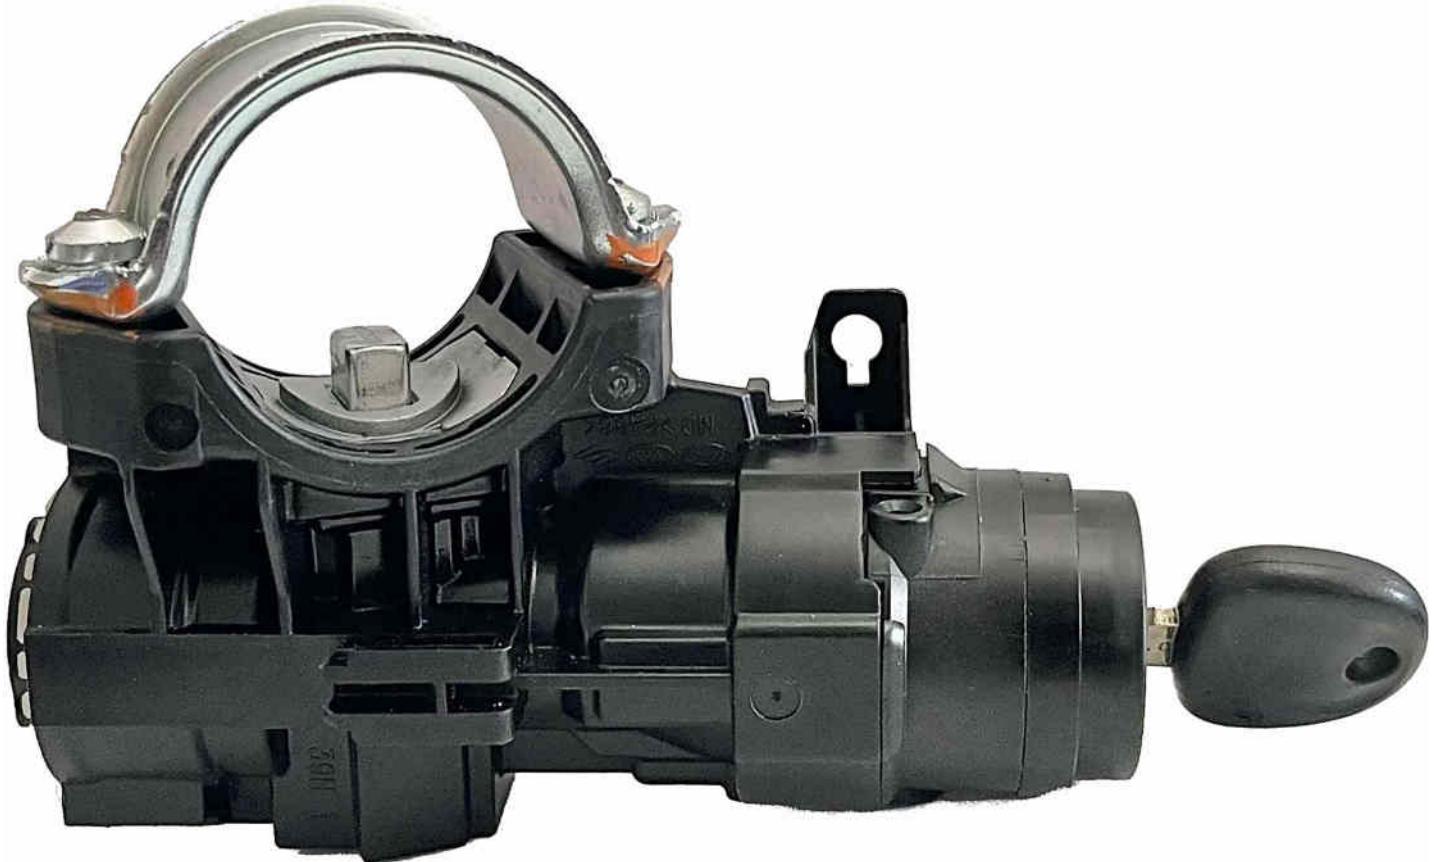
2011-16 Hyundai Elantra Ignition Assembly

Starting in models first introduced in 2011, Hyundai began replacing the metal ignition assemblies with hollow plastic that was designed to reduce their manufacturing costs.

Beginning with vehicle models introduced globally in 2011, Hyundai replaced the previously robust metal ignition assemblies with cheaper, fragile plastic assemblies. These plastic assemblies utilized [thin-wall construction](#) intended for portable electronics, and they failed to provide the security standards of the metal assemblies they replaced. From a logical and engineering standpoint, the new plastic assemblies had been designed for use in combination with immobilizer technology.

The plastic ignition assembly has different physical properties than its metal predecessor, allowing the housing to flex, deform, and fracture more easily. Hyundai failed to make appropriate design changes to the plastic housing or its mechanisms to bolster their effectiveness and counteract the plastic's tendency to deform, which increases the likelihood of malfunctions.

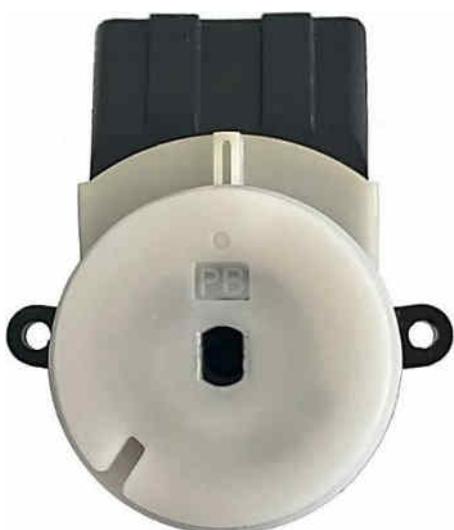
"PB" ignition switch

Our investigation of the 2011–2016 Hyundai Elantra ignition switch revealed weak turning resistance. Comparative measurements of the force required to turn the switch were below our equipment's minimum threshold and registered as zero (undetectable). We plan to acquire specialized equipment capable of measuring lower forces and conduct further testing in the near future.

We observed two conditions that increased the likelihood of an inadvertent ignition shut-off scenario:

The automotive industry became aware of the risks associated with low-resistance ignition switches—often introduced for a “sporty” feel—approximately four years after Hyundai introduced the “PB” switch into the U.S. market. The 2011–2016 Elantra ignition switch, with its low turning resistance, is particularly vulnerable to this condition.

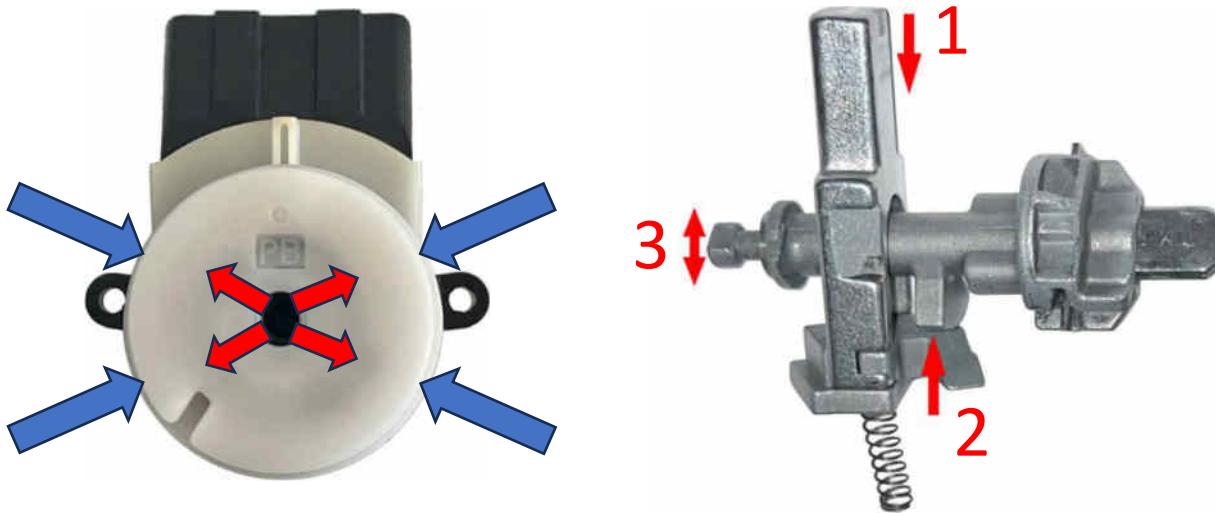
Vibration and shock from the steering column can propagate into the ignition switch, altering its mechanics and reducing the force required to turn it. These forces are transmitted through the switch casing and mated ignition housing, behaving similarly to energy transfer in billiard balls—a well-understood engineering concept (illustrated by blue arrows).

Vibration from the steering column and the shocks of repetitive bumps can push down on the lock-bolt (1); the lock assembly’s spring will push the lock back up, and these opposing forces can cause the lock assembly to act like a reciprocating jackhammer against the tumbler rod’s cam (2); This vibration can then transfer through the tumbler rod and into the ignition switch (3).

The effect of vibrations transferred into the ignition switch acts on its mechanics from both an external-to-internal, and an internal-to-external direction simultaneously, which can momentarily reduce the switch’s resistance and the required force to turn it.

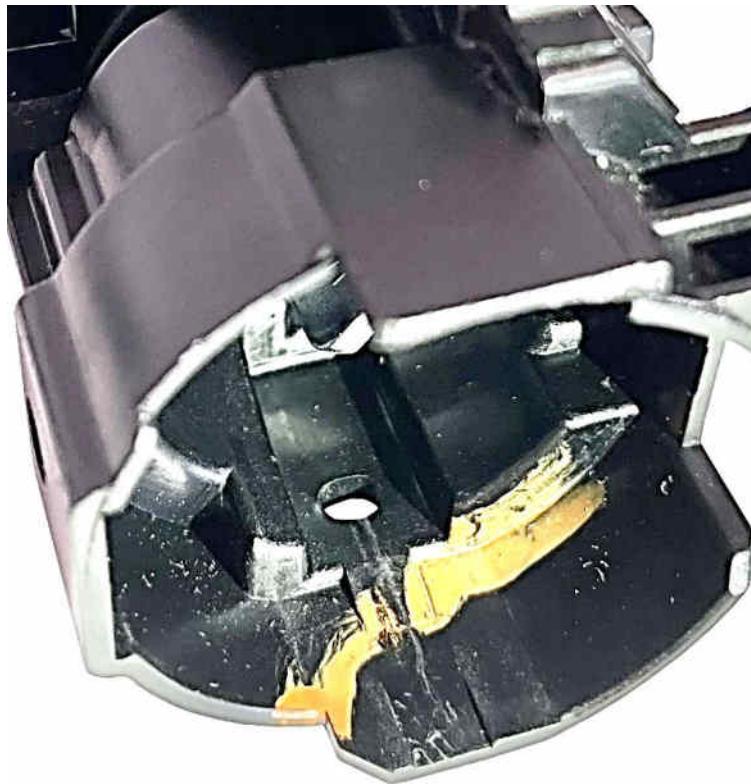
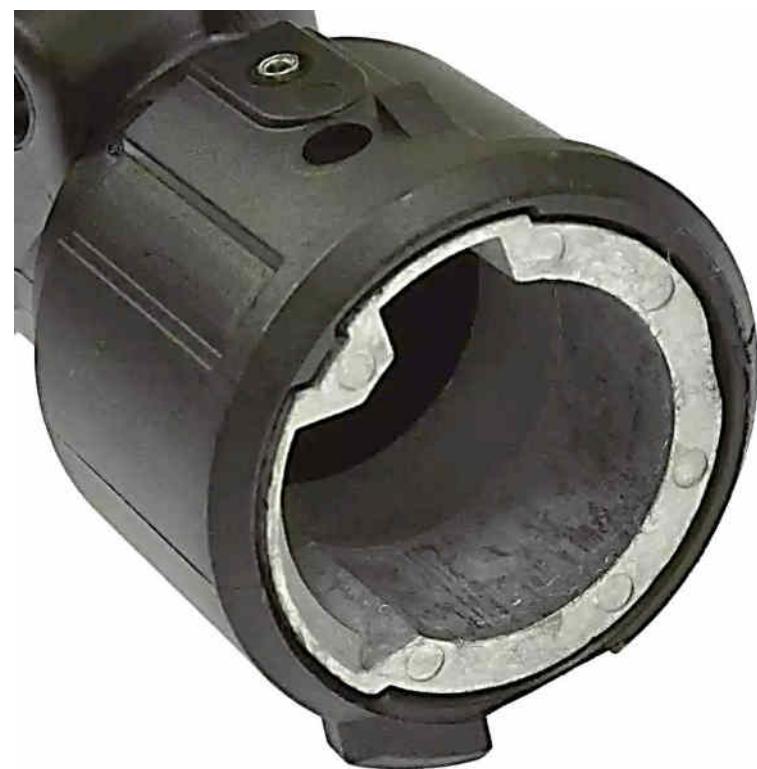
Comparison of Hyundai Elantra (2015) ignition housing to Ford Focus (2008)

Defect: The tab's edge (ARROW) makes approximately 1 mm of contact with the plastic housing, which over time carves and deforms the plastic, creating a small channel or ramp. This design flaw has resulted in millions of defective ignition assemblies in which the tumbler-rod's tab can retract on its own, allowing the cylinder to turn to LOCK without the key being pushed into the cylinder.

As a result, this critical safety mechanism is circumvented. The plastic ignition assembly lacks adequate reinforcement, rendering the push-to-lock mechanism defective and unreliable.

AutoSafe contends that this defect within the affected ignition assemblies concerns an important safety feature that should be recalled. We suggest replacement with a metal reinforced housing.

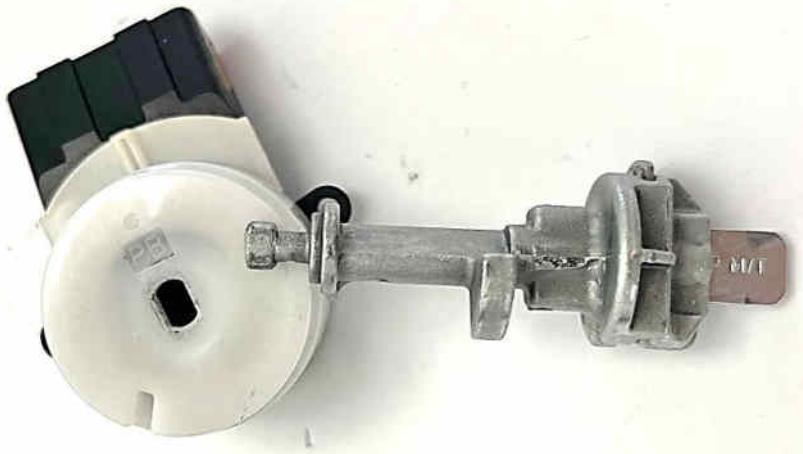
After examining a 2011–2016 Elantra ignition assembly, we observed that the tumbler-rod remains secured within the ignition switch in all positions except when the ignition cylinder and tumbler-rod are turned to the ON position. In this state, the tumbler-rod can freely slide out of the ignition switch. This behavior is consistent across multiple Hyundai and Kia models that utilize the same ignition switch component.

The tumbler-rod's critical role is to disable the steering-lock assembly, and for safety, it must remain securely retained to prevent a steering lock-up while driving. However, when the ignition is in the ON position, no mechanism secures the tumbler-rod within the housing.

This design raises concerns: allowing the tumbler-rod to disengage while the vehicle is in operation introduces the potential for unintended steering lock activation. A more robust design would release the tumbler-rod only in the Accessory (ACC) position, thereby reducing the risk of steering malfunctions during driving.

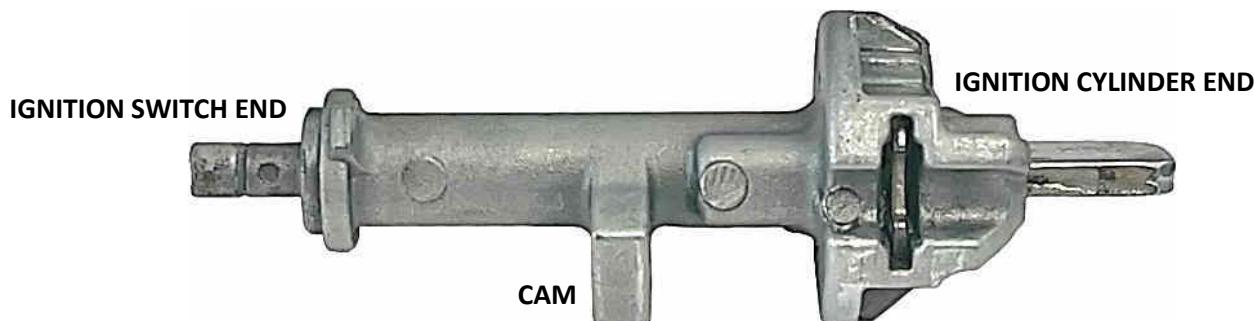
HYUNDAI Tumbler Rod (2011-16 Elantra)

To reduce the risk of lateral movement of the tumbler-rod in the ON position, Hyundai designed the 2011–2016 Elantra's tumbler-rod with a small 1 mm catch that makes contact with the edge of the lock-bolt assembly, intended to act as a stop against sideways movement.

However, the contact surface between the tumbler-rod catch and the lock-bolt assembly is minimal—limited to roughly 1 mm at an angled edge. Because both parts feature rounded edges and a sloped profile, the catch can slip past the lock-bolt's edge under certain conditions, creating the potential for a steering-lock malfunction.

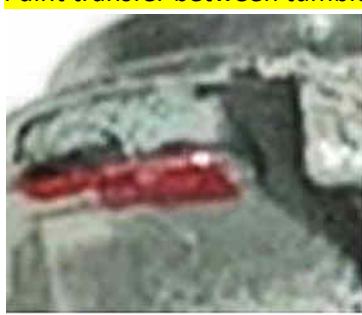
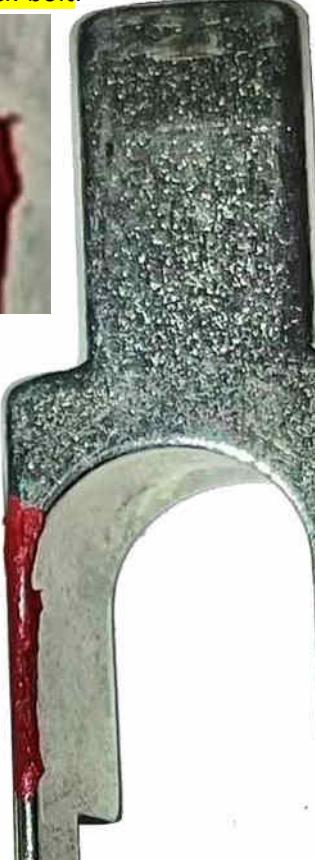
1 mm

Paint transfer between tumbler-rod and lock-bolt.

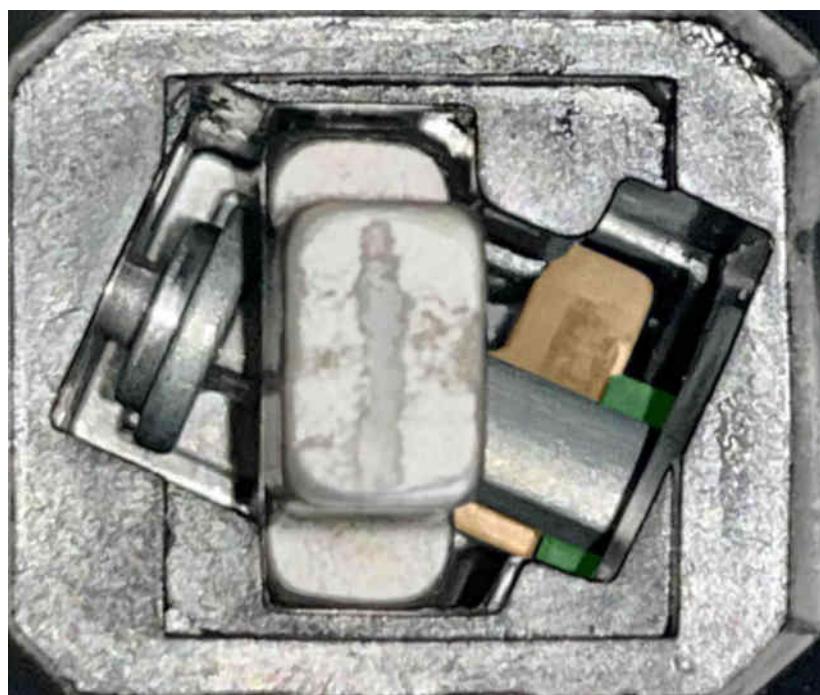
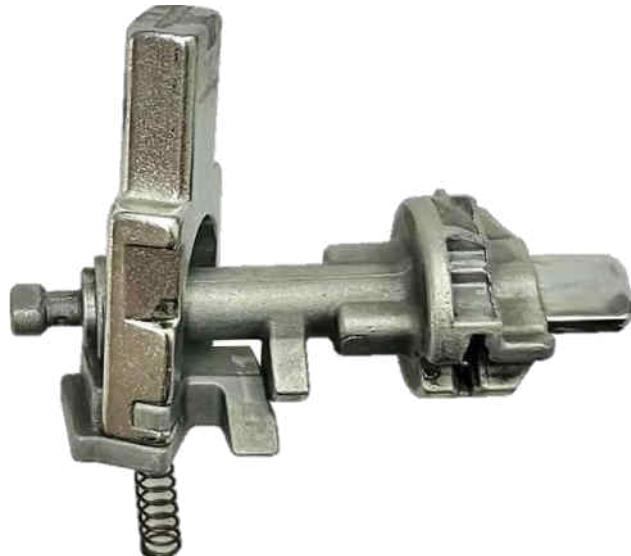
If the tumbler-rod moves laterally by as little as 2 mm while in the ON position, it can slip off the lock's base, causing the lock-bolt to spring up and resulting in a steering lock-up malfunction.

The following image illustrates an internal malfunction in which the tumbler-rod has shifted laterally by 2 mm, causing the tumbler-rod's cam (highlighted in green) to slip off the steering-lock's base (highlighted in orange).

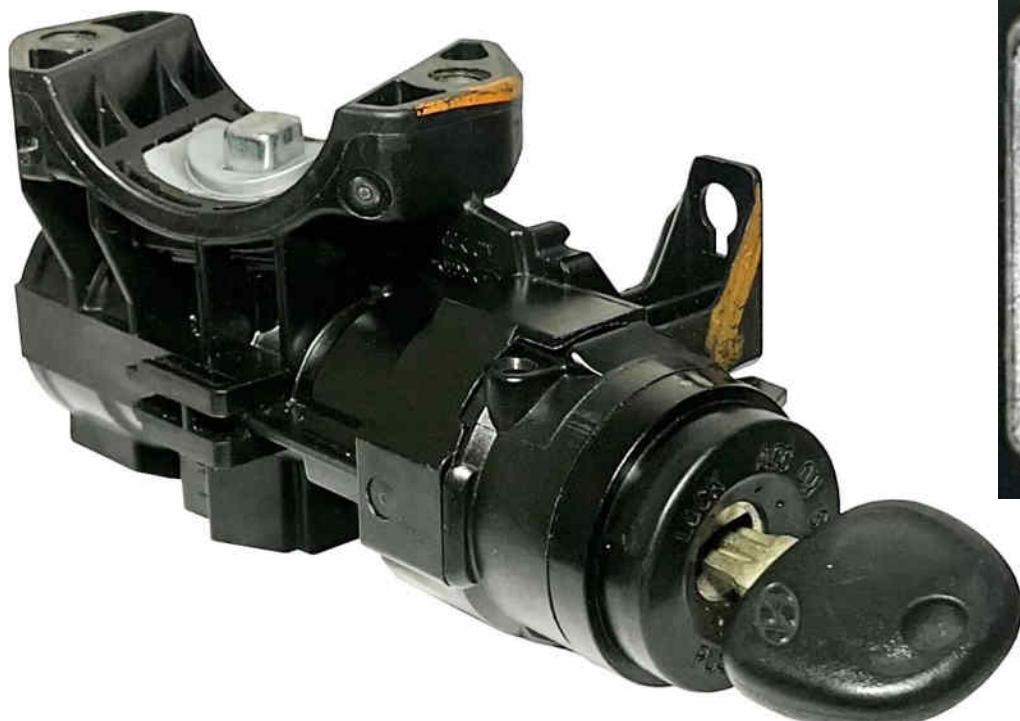
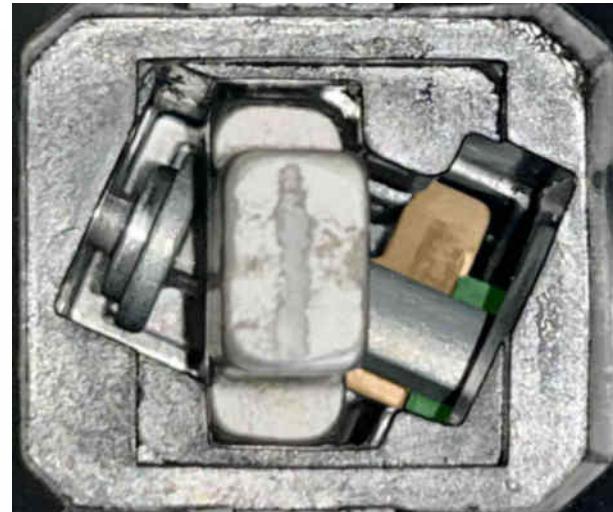
B) The assembly housing lacks a raised stop-channel (red block) for the tumbler-rod cam, which would otherwise prevent lateral movement in the ON position.

The steering lock has fully deployed while the ignition cylinder is turned to the ON position.

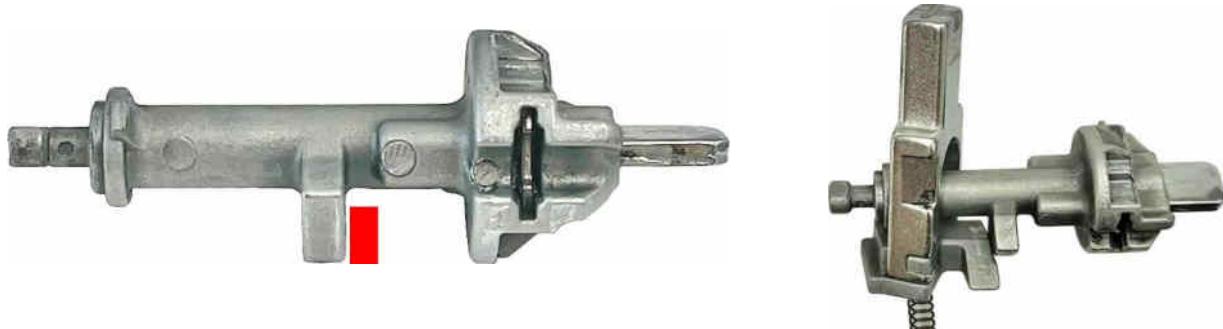
The image below illustrates this design improvement: the stop-channel (red block) physically restrains the tumbler-rod cam, blocking unwanted lateral movement and ensuring it cannot disengage from the lock's base (shown to the right).

Hyundai subsequently addressed this issue by incorporating a raised stop-channel into later ignition assembly housings. This feature ensures that the tumbler-rod cam remains laterally secured while in the ON position, preventing it from slipping off the lock's base and inadvertently deploying the steering lock.

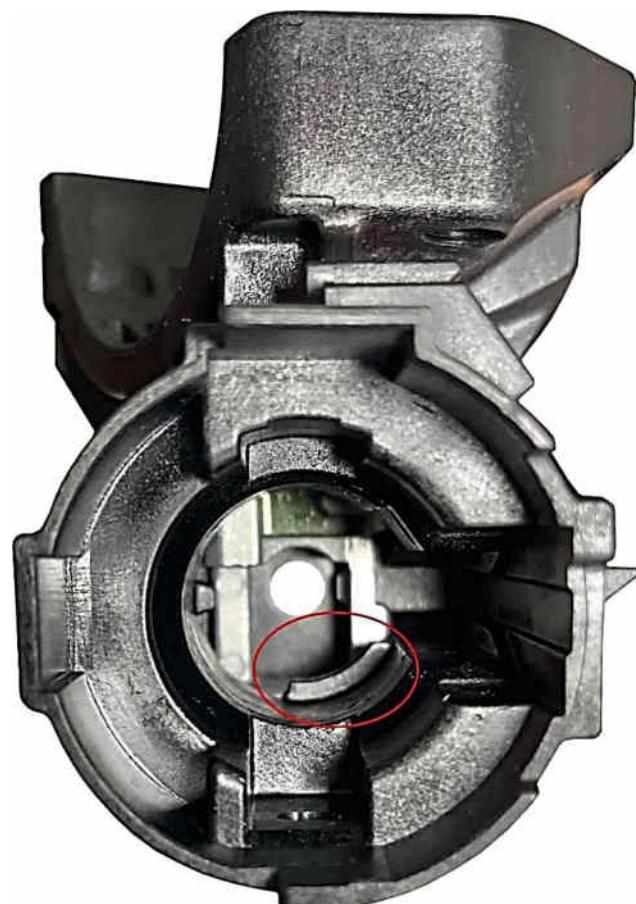
Later Generation Housing

Below, we compare the 2011–2016 Elantra ignition assembly (left) with a later-generation Hyundai housing. In the updated design, a raised stop-channel (circled in red) has been added to the assembly housing—an important feature absent from the 2011–2016 design.

Note: To determine whether Hyundai had retroactively corrected this issue, we purchased a replacement ignition assembly for the 2011–2016 Elantra. Disappointingly, these assemblies continue to be sold without the stop-channel, leaving the vulnerability to lateral movement unresolved.

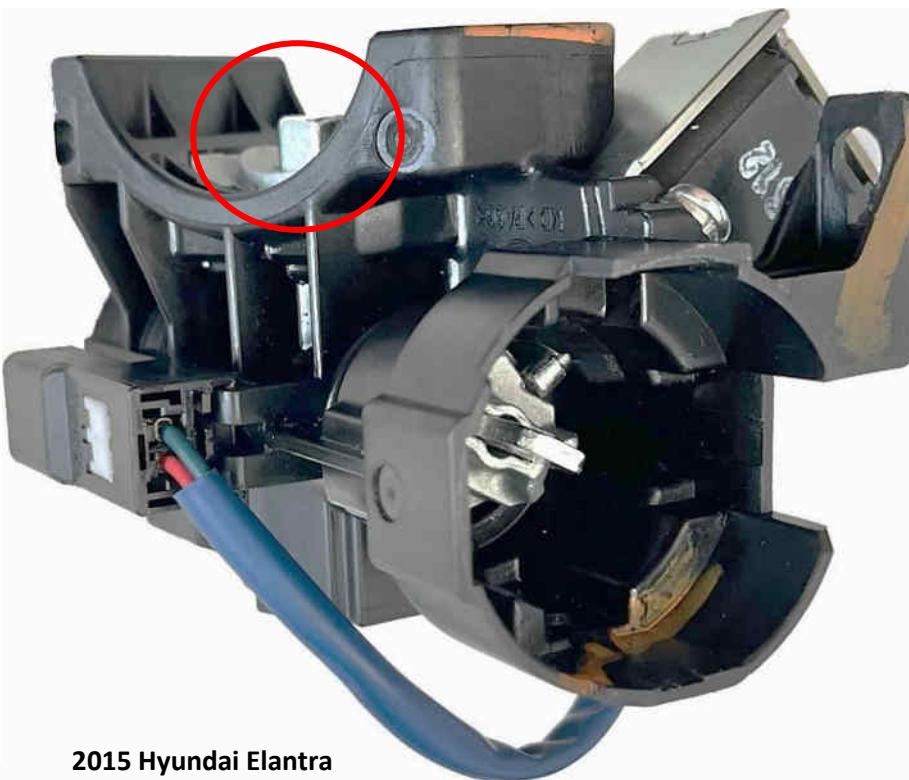
2015 Hyundai Elantra

Furthermore, our testing on a 2012 Elantra showed that if the interlock fails to deploy the pin due to obstruction or burnout, the car will still allow the transmission to shift. Permitting a shift into DRIVE without the interlock deployed constitutes an automatic noncompliance with 49 CFR 571.114 [S5.2](#) & [S6.2](#).

If interlock solenoid is damaged or fails to properly deploy pin, the vehicle will still shift into **DRIVE** and **won't** alert the driver.

This may be interpreted as a violation of 49 CFR 571.114 [S5.2](#) and/or [S6.2](#) (test procedures).

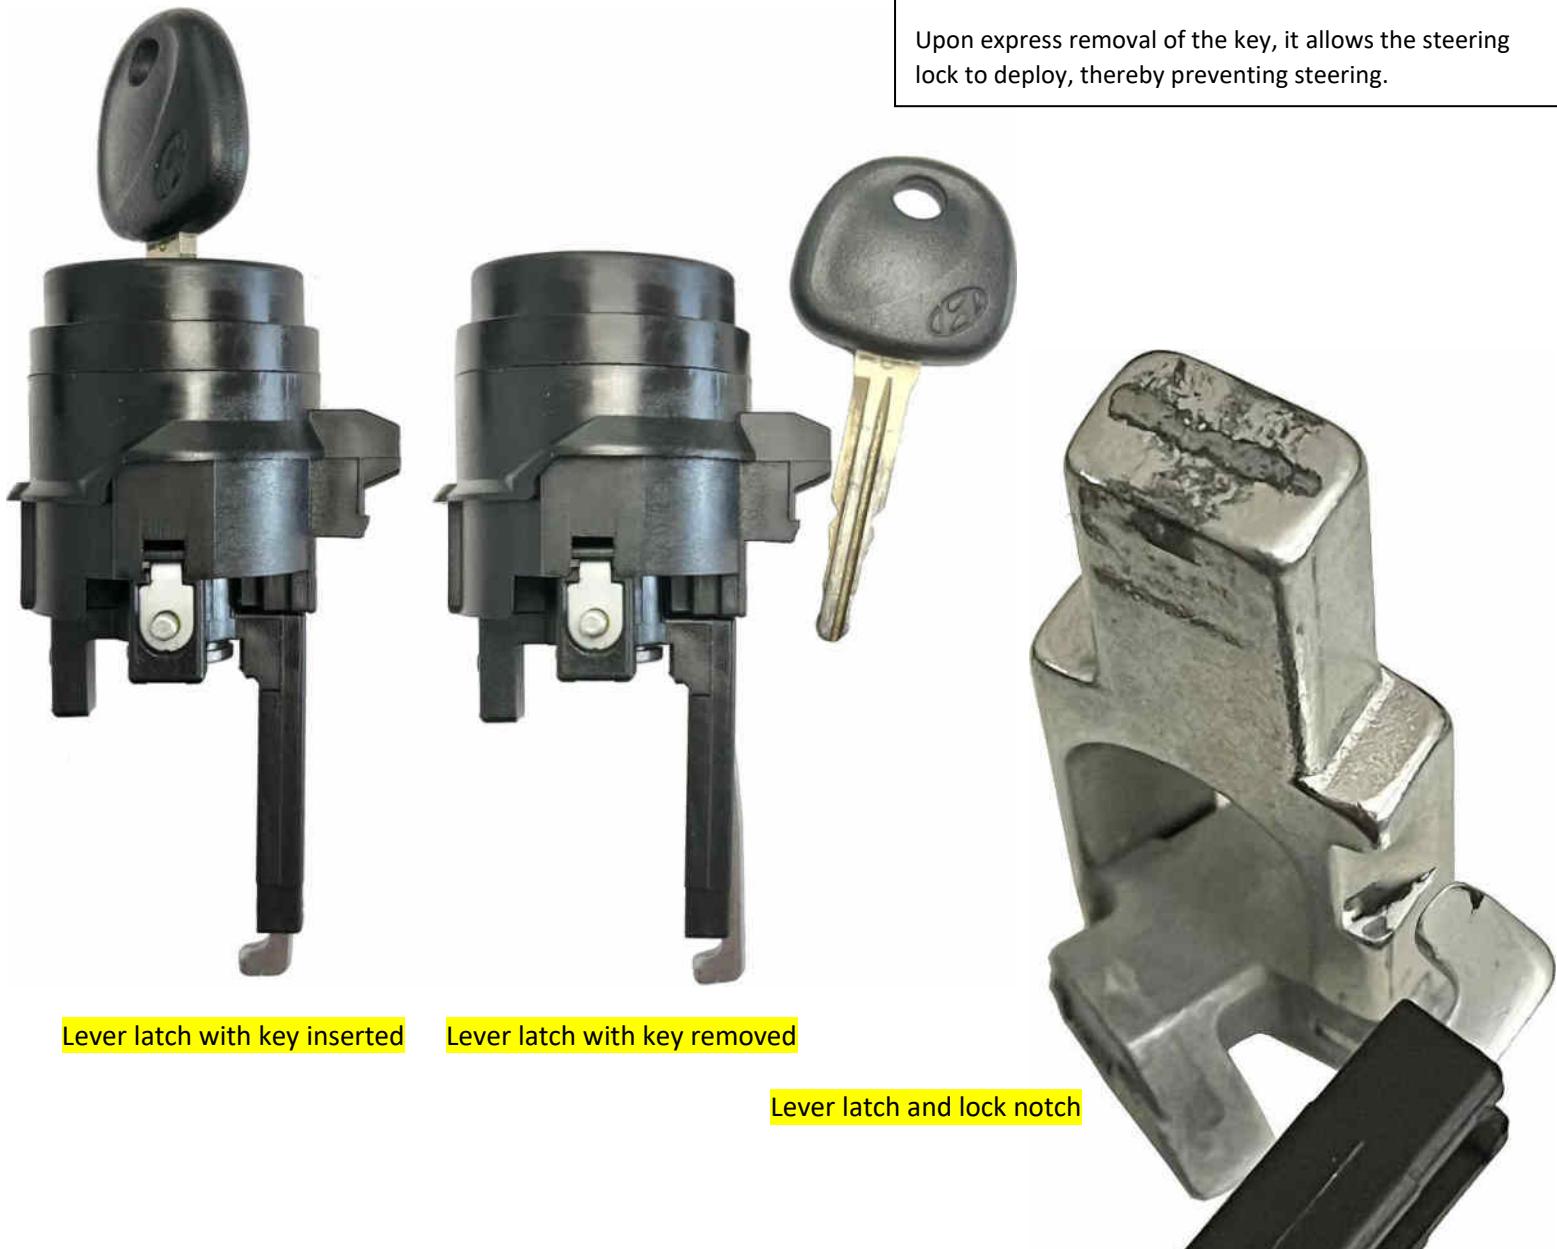
It was concerning that the lock's notch and lever have a very small contact area of only a few millimeters, with both components featuring rounded edges. This mechanism relies on tight tolerances to function effectively, yet the lock assembly is poorly engineered and manufactured, composed of multiple pieces that easily separate and move within the assembly.

The notch has a maximum depth of 2 mm, tapering to nothing, and the combined effects of rounded lever edges and loose tolerances reduce the effective contact to roughly 1 mm.

We therefore contend that any lateral movement of the tumbler rod caused by bumps or potholes could also overcome the lever latch's spring tension.

The root cause of this defective mechanism appears to be the approximately 1 mm of meaningful surface contact between the latch and lock notch, combined with the substandard construction of both the lever mechanism and the overall ignition assembly.

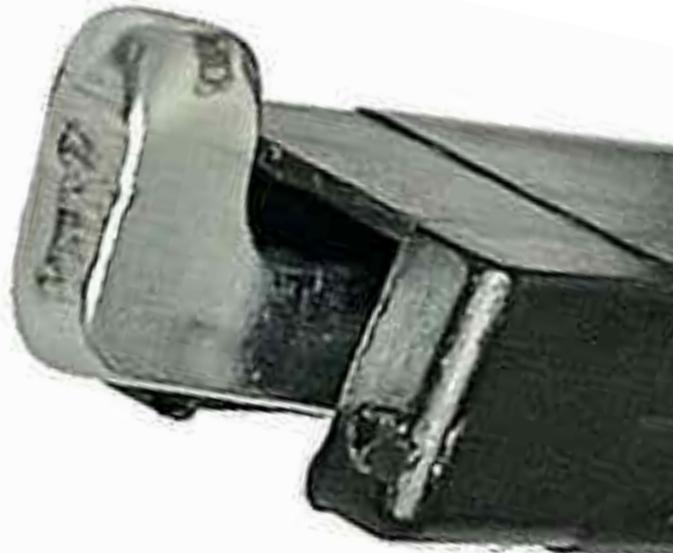
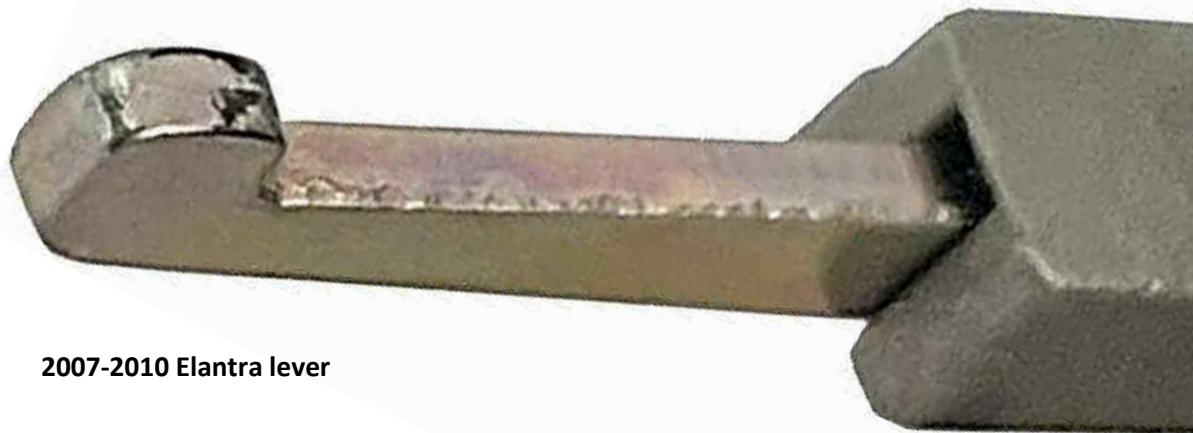
2011-2016 Elantra lever

In the 2011–2016 Elantra, we observed that the side of the lever contacting the lock is noticeably more rounded and sloped compared to the opposite side. Additionally, the entire lever exhibits more play than the lever used in older-generation Elantras. The combination of the sloped edge and increased play further reduces the effective surface contact between the lever and the lock's notch, thereby decreasing the overall effectiveness and reliability of the mechanism.

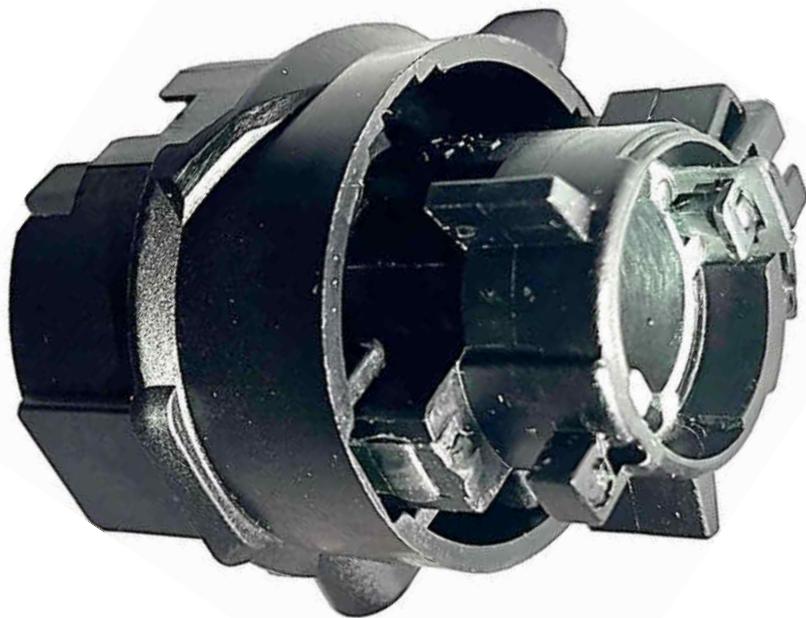
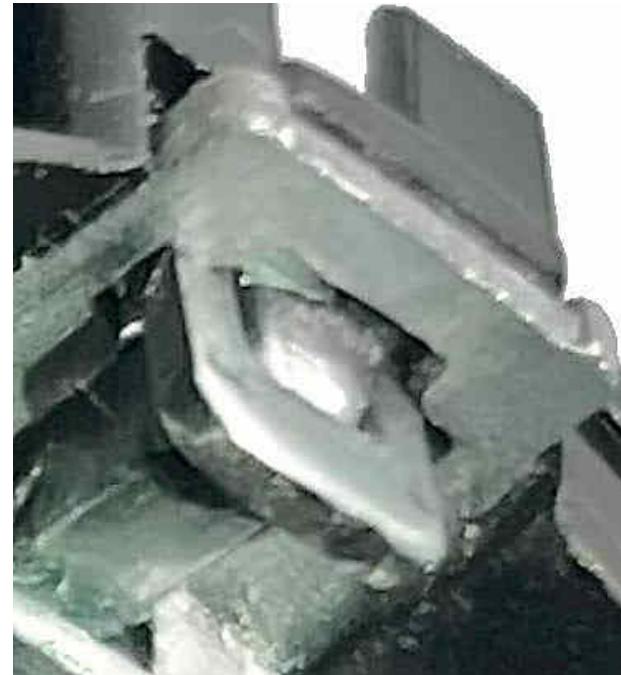
- 2011-2016 Elantra ignition cylinder with key cylinder removed and lever tab exposed

The lever latch is attached to a thin 1 mm metal tab that lifts when the key is inserted, actuating the mechanism. This tab only contacts the lever at its very edge and is loosely fitted. As a result, it makes less than 1 mm of effective contact. The loosely secured tab can move or “wiggle” like a loose tooth, and if it were to dislodge, the latch would fail to actuate, rendering the safety mechanism ineffective.

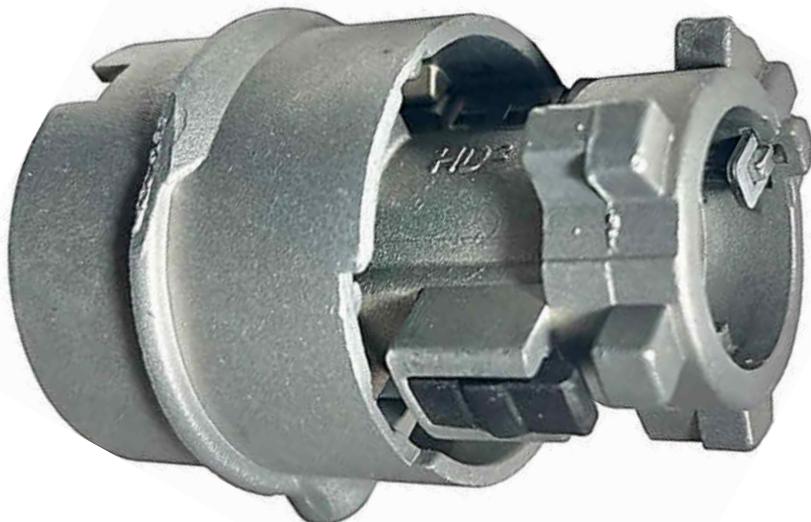
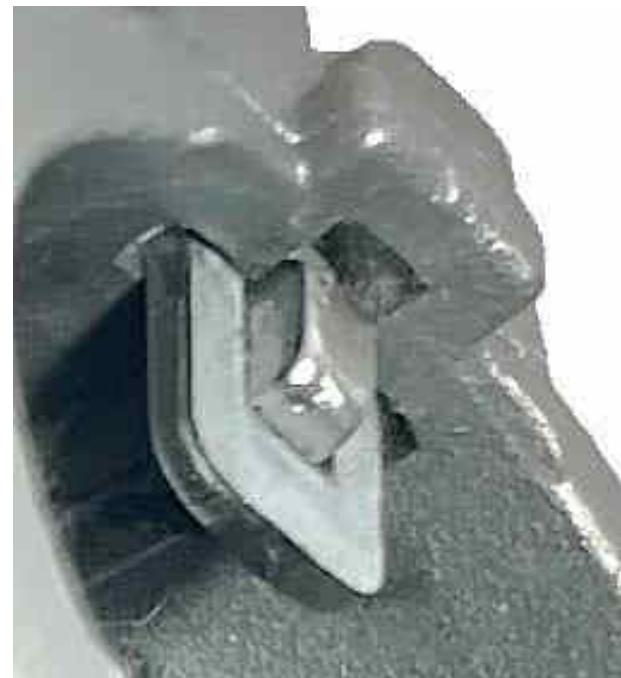
- 2007-2010 Elantra ignition cylinder with key cylinder removed and latch lever tab exposed

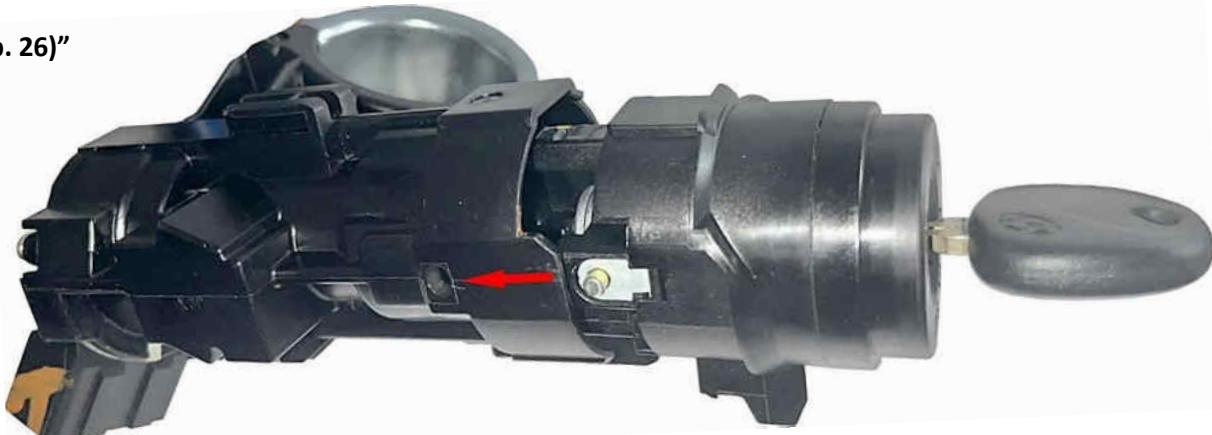
Lever Latch – Cracked or deformed plastic housing

The ignition cylinder is held in the plastic housing by a single locking pin. If the housing becomes slightly deformed or cracked in a way that compromises the pin's retention, the cylinder—and its attached latch mechanism—can shift a few millimeters away from the lock assembly notch. This movement would render the key latch lever ineffective at preventing a steering lock-up while driving.

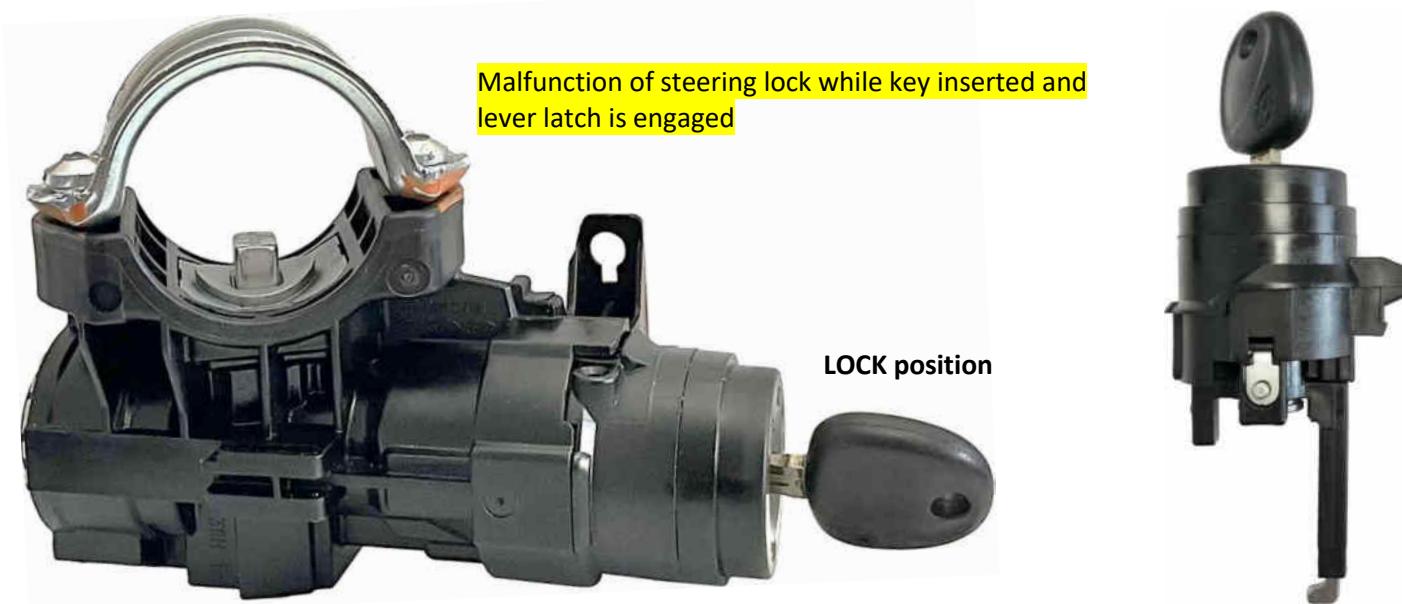
Lever Latch – FMVSS 114 S5.1.1

We contend that the lever latch fails to satisfactorily meet the FMVSS 114 S5.1.1 standard, which requires that an anti-theft device (steering lock) deploy only upon removal of the key. The key-removal requirement is the standard's built-in safety measure to prevent inadvertent steering lock-ups while the vehicle is in motion.

We tested the 2011–2016 Elantra lever mechanism by turning the ignition to LOCK while keeping the key inserted. Our testing showed that the lever's spring tension can be easily overcome with taps or gentle impacts simulating bumps and potholes. These shocks allowed the lock to bypass the lever latch mechanism and deploy while the key remained inserted.

We determined that the lever mechanism intended to enforce the key-removal portion of S5.1.1 is neither effective nor reliable. This is likely due to the latch's limited 1 mm of effective contact with the lock assembly notch and the excessive play present in both the lever and the lock assembly.

The steering lock prevents steering of the vehicle, and to satisfy FMVSS 114 S5.1.1(b), it must not deploy until the key is removed from the ignition. While other (flawed) safety mechanisms may be cited, federal standards specifically apply to the lever latch mechanism, which must be evaluated on its own to determine compliance with S5.1.1(b).

The lever latch mechanism has failed to meet a reasonable standard of quality (substandard) and is therefore ineffective at upholding the anti-theft mandate's innate safety component. This defective component should be recalled so that ignition cylinders and lever latch mechanisms can be replaced with higher-quality parts that reliably prevent inadvertent steering lock-up while the key remains inserted.

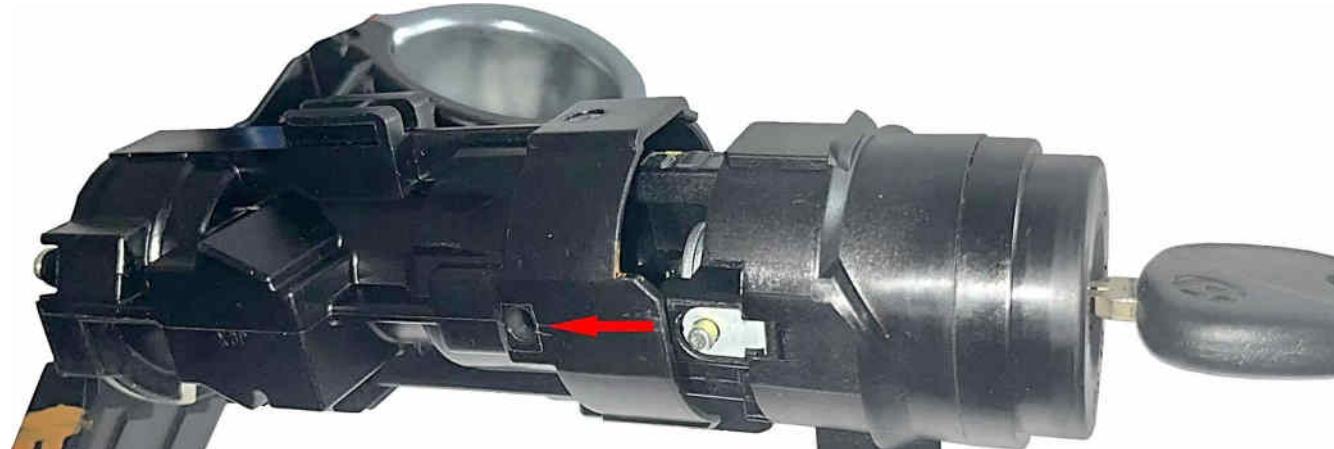
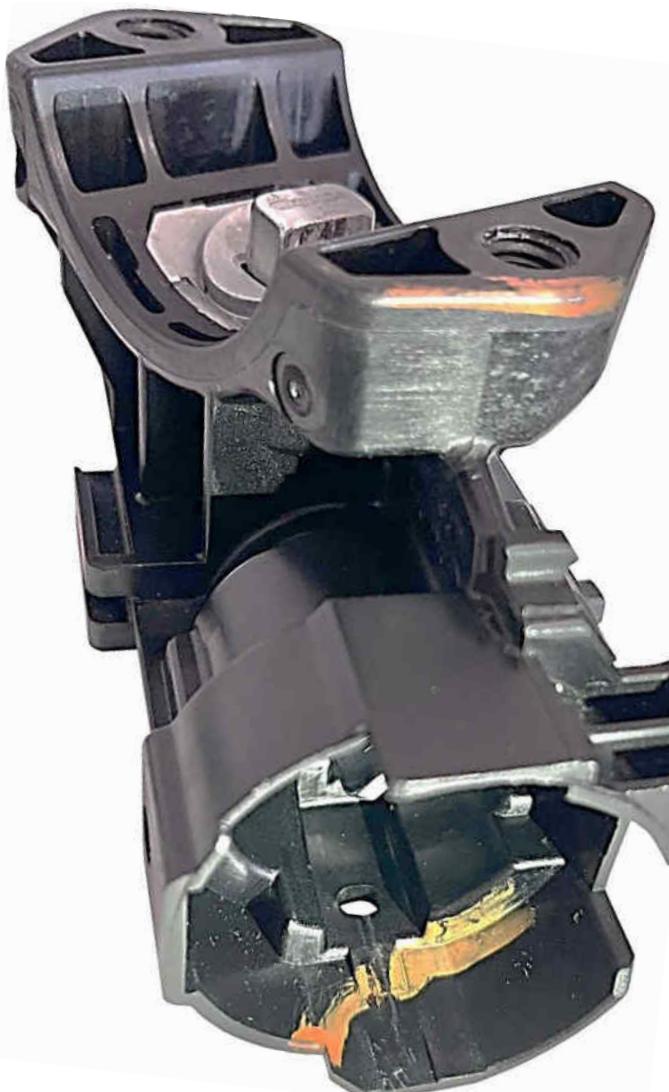
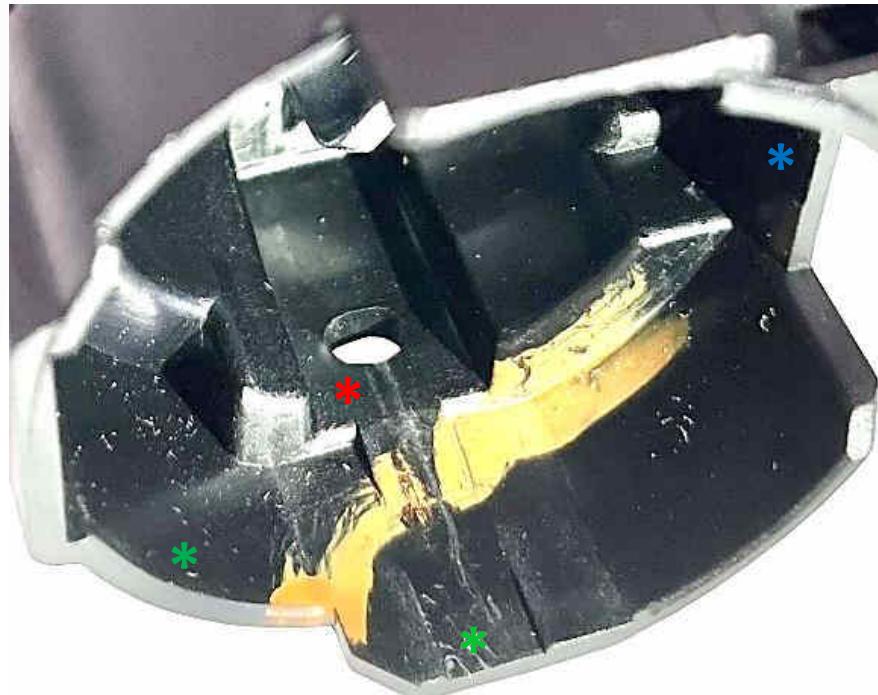
The ignition assembly's 1.0 mm thin-walled plastic housing appears to have been engineered with the assumption that an electronic immobilizer would provide the primary theft deterrent. In such a configuration, the housing itself is not designed to resist tampering or forced entry, but rather to function as a placeholder for the immobilizer system.

* 1.3 mm

* 1.5 mm

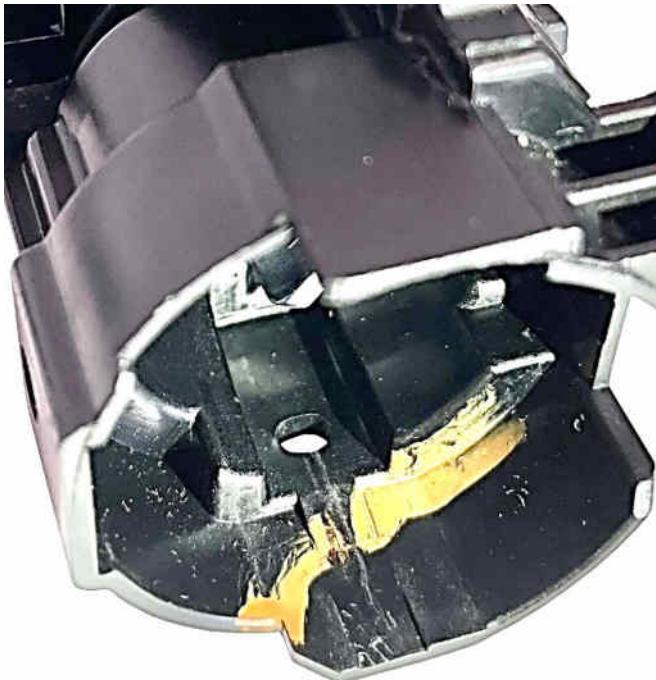
Hyundai Elantra (2015/2016) - \$740.58

Instead of meeting U.S. quality expectations, the focus shifted to cutting costs and boosting profits with substandard parts. Competition should drive better products, but American companies shouldn't lose ground at home because newer players gain an advantage by cutting corners.

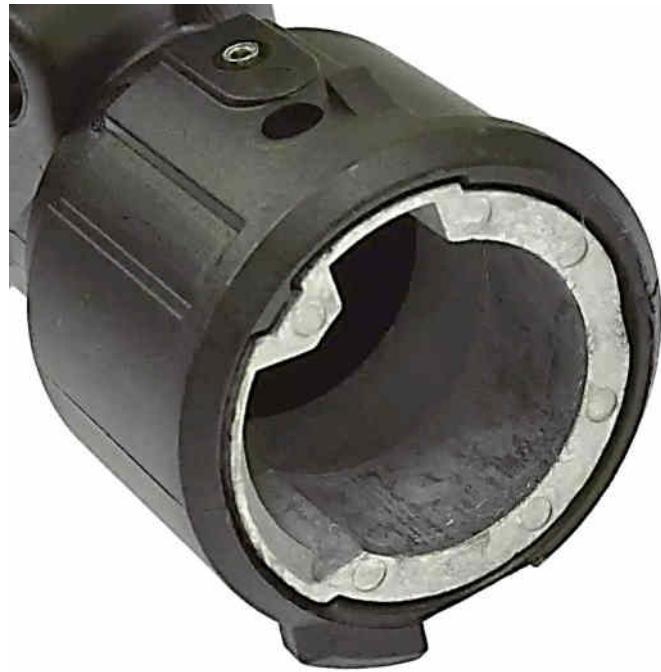
Ford Focus (2008) - \$215.00

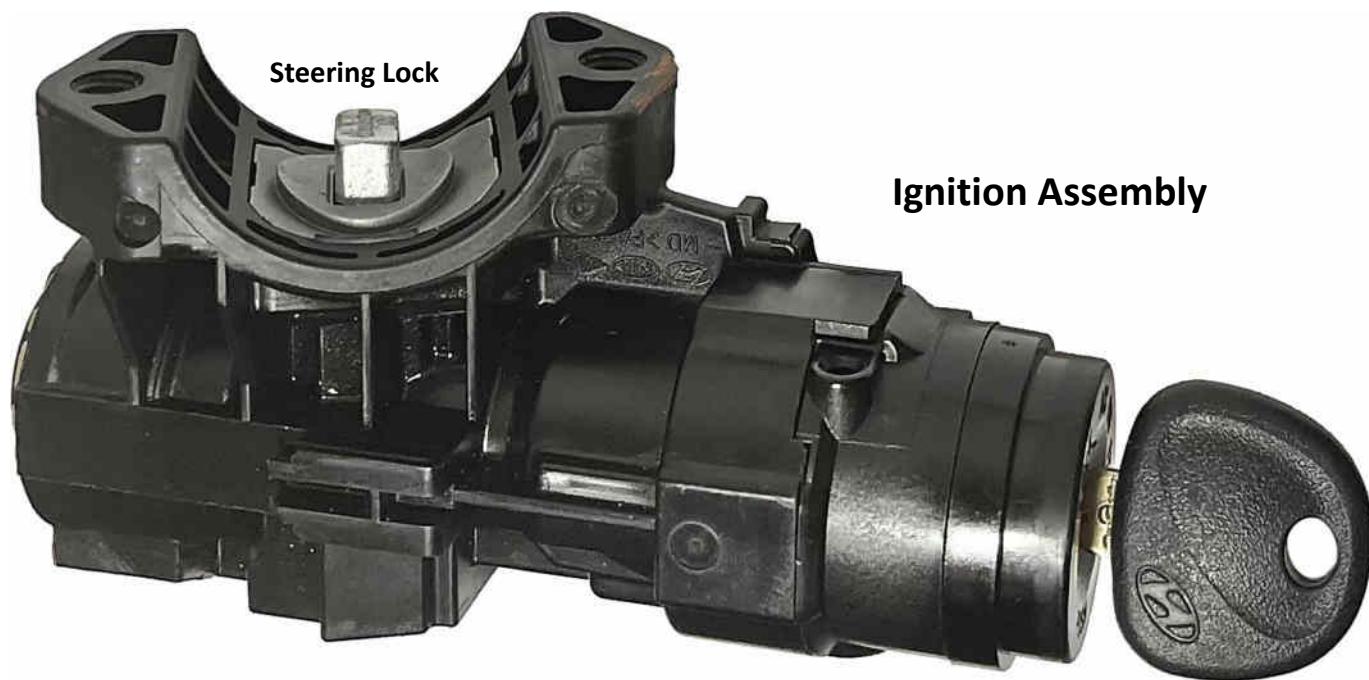
The ignition assembly's plastic housing was not engineered to withstand the extreme stresses produced by Hyundai's steering-wheel lock mechanism. Instead, it was manufactured with hollow crevices to reduce plastic use and lower costs. The wall thickness around the steering lock varies but averages approximately 2 mm.

It is evident that the torque transmitted through the steering column and onto the ignition assembly's steering lock imposes extreme stress on the fragile plastic housing. This excessive stress can cause deformation and/or stress fractures within the housing's thin plastic walls.

Based on our examination of the steering lock's effect on the ignition assembly, we conclude that this accessory can inadvertently damage ignition components and poses a significant safety risk. Accordingly, it should be subject to an immediate recall.

- Recall and replacement of ignition assemblies in all vehicles where Hyundai steering-wheel locks were installed following an attempted theft, regardless of whether visible damage is present.
- Recall and replacement of ignition assemblies in all vehicles where Hyundai steering-wheel locks were installed and children may have been left unattended, as the lock's bright color and handle design could have encouraged tampering and further compromised the ignition assembly.

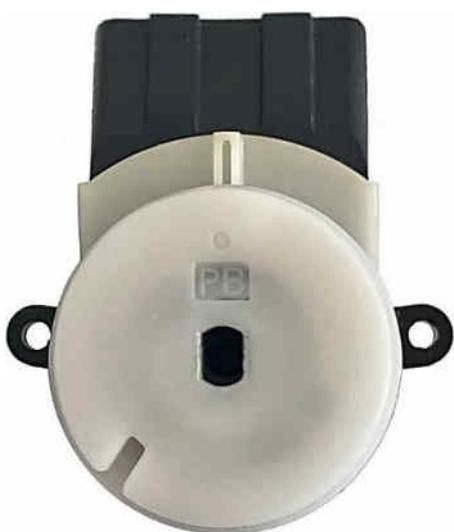
"PB" ignition switch

Our investigation of the 2011–2016 Hyundai Elantra ignition switch revealed weak turning resistance. Comparative measurements of the force required to turn the switch were below our equipment's minimum threshold and registered as zero (undetectable). We plan to acquire specialized equipment capable of measuring lower forces and conduct further testing in the near future.

However, Hyundai was aware of the risk of inadvertent steering-lock deployment due to low turning resistance and implemented a "Push-to-Lock" safety mechanism within the tumbler rods paired with this switch. This mechanism prevents the ignition from inadvertently turning to the LOCK/OFF position while the vehicle is in motion. However, it does not mitigate the risk of the switch inadvertently turning to ACC, which can shut off the engine and power systems during operation.
