Flawed Logic: The Hyundai Anti-Theft Campaign

An analysis of the campaigns to address rampant theft
of Hyundai and Kia vehicles across America

FULL REPORT – DEFECTS & ANTI-THEFT CLAIMS

Rev. 1/22/2026

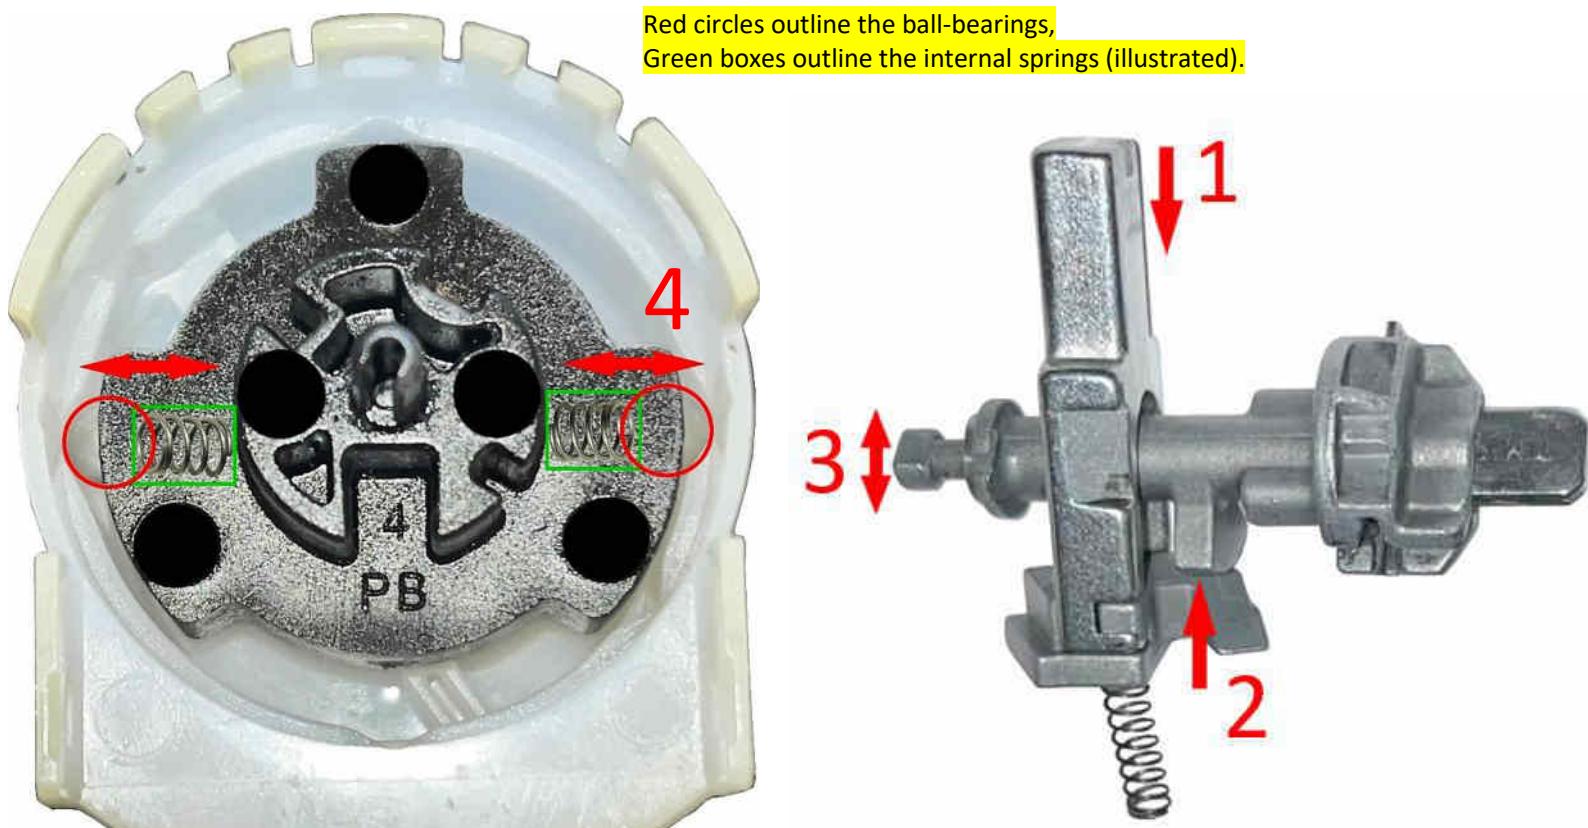
Vibration from the steering column and the shocks of repetitive bumps can push down on the lock-bolt (1); the lock assembly's spring will push the lock back up, and these opposing forces can cause the lock assembly to act like a reciprocating jackhammer against the tumbler rod's cam (2); This vibration can then transfer through the tumbler rod and into the ignition switch (3).

The effect of vibrations transferred into the ignition switch acts on its mechanics from both an external-to-internal, and an internal-to-external direction simultaneously, which can momentarily reduce the switch's resistance and the required force to turn it.

Red circles outline the ball-bearings,
Green boxes outline the internal springs (illustrated).

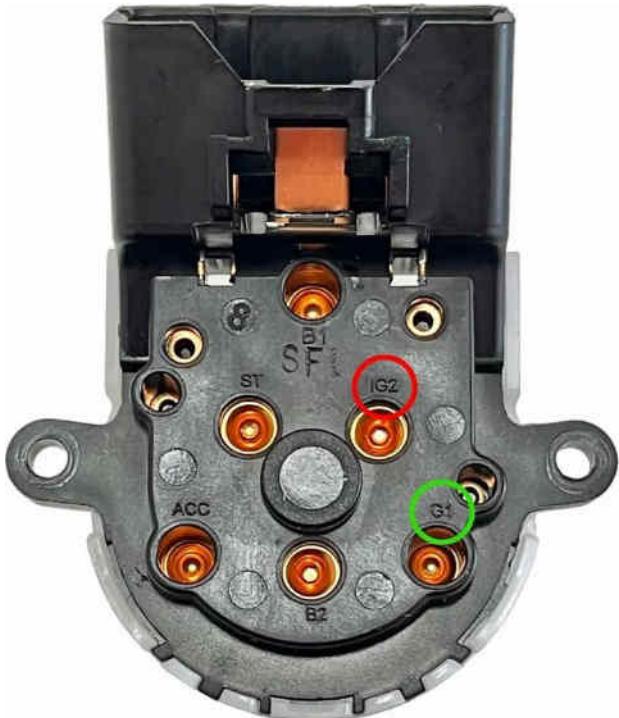
2011-20 Elantra (PB White Shell)

We procured new replacement ignition switches as part of entire replacement assemblies produced for the 2011-2016 & 2021+ Elantra. We noted that both switches share the same typo for Ignition-1 on the plastic casing as "G1" (circled green) instead of "IG1" (older examples of this casing and the most current casing's pin connector both list it correctly as "IG1"); we can also see that Ignition-2 is spelled correctly on both casings as "IG2" (circled red).

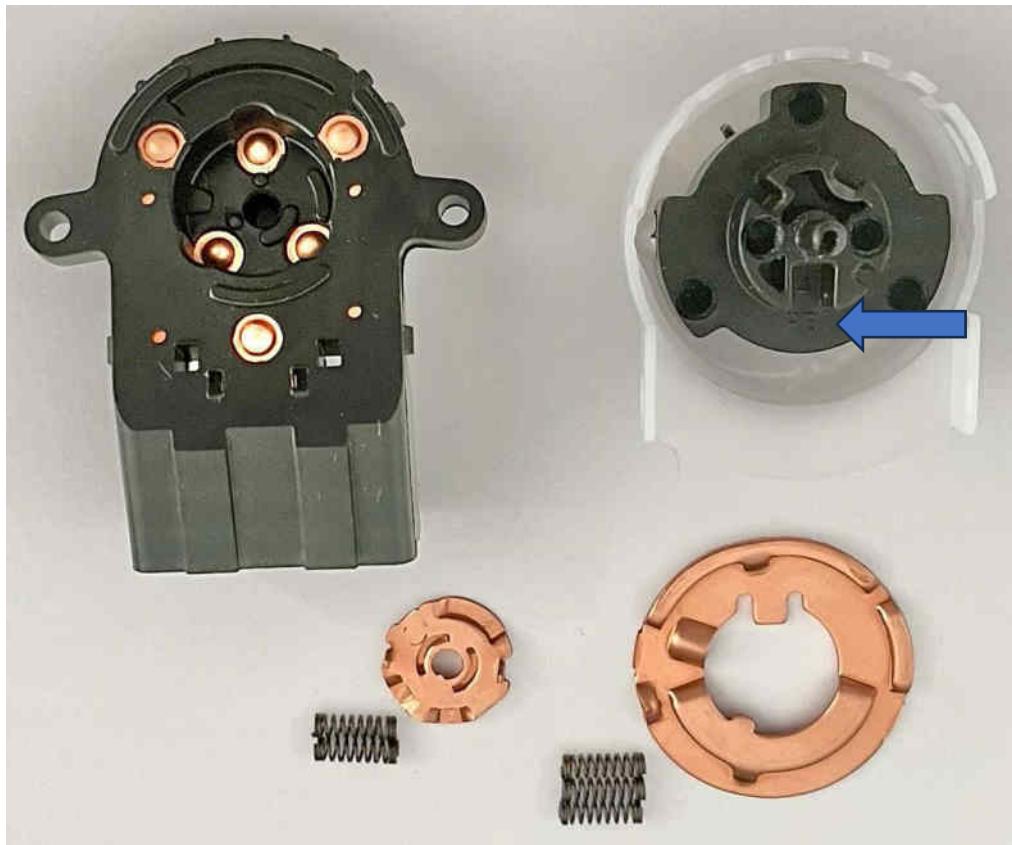
Upon deeper examination, it appeared that the two ignition switches used identical components throughout. The detent switching mechanism even had the same part markings (i.e., "PB"). The only obvious difference was the white and black shell.

Note: "PB" switch's detent mechanism marked as "PB."

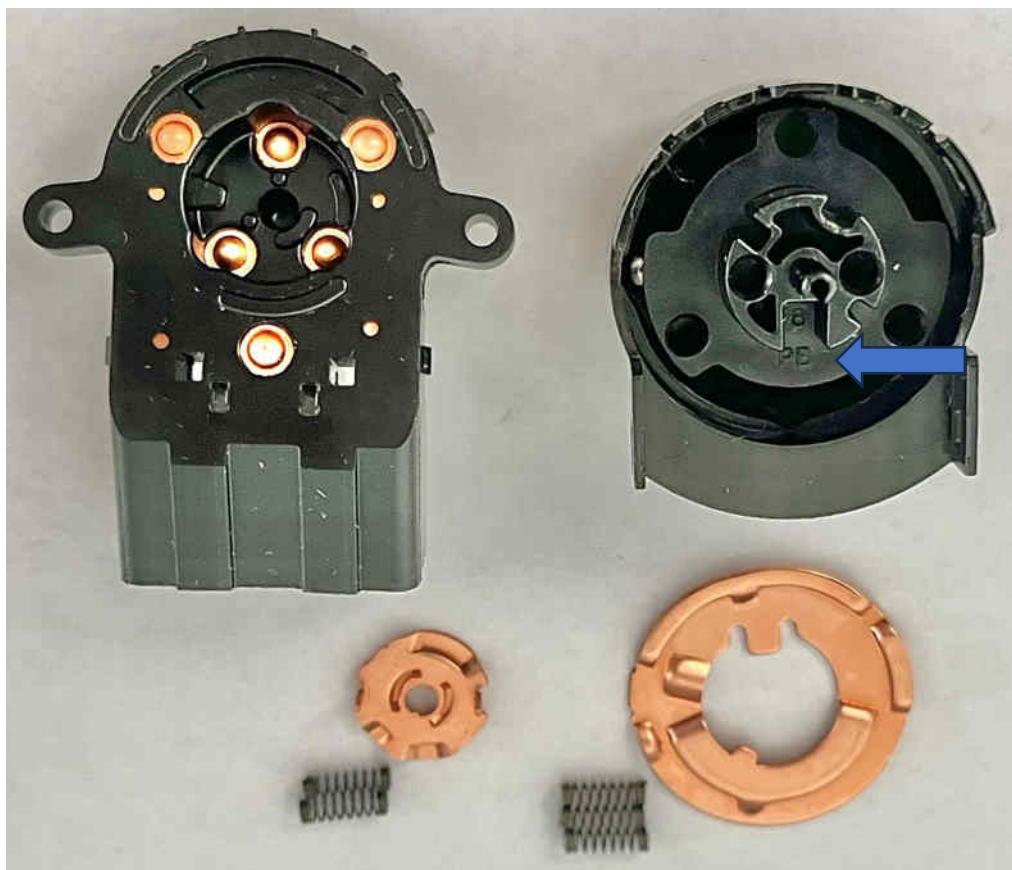
Note: "CD2" switch's detent mechanism also marked as "PB."

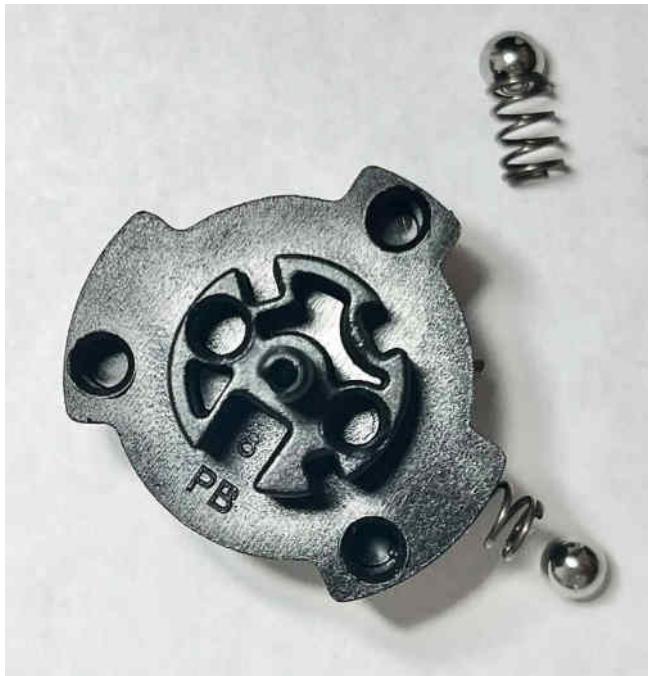
New CD2 switch detent mechanism (marked "PB")

We discovered the answer upon further examination of the detent-switching mechanism. The new black cover switch uses 2 stiffer springs within its ball-bearing and detent switching mechanism. These stiffer springs resist compression more than the old springs and increase the pressure of the ball-bearings against the shell's detents, thereby, significantly increasing the force required to turn the key from ON to ACC.

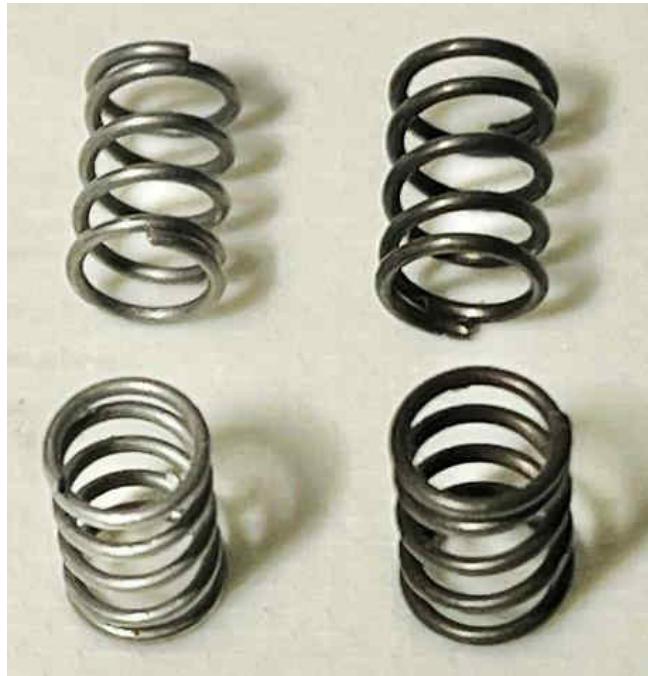
Original springs on left (silver) & new springs on right (black)

AutoSafe's evaluation proposes issuing a recall for the ignition switch component within the above listed vehicles in order to replace the 2 internal soft springs with the stiffer springs that increase switching resistance.

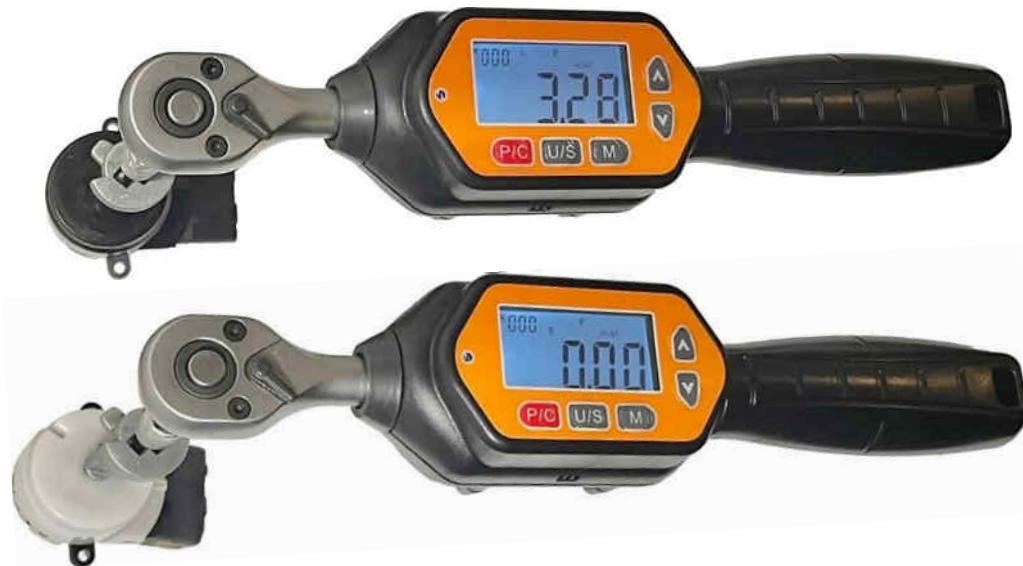
We also attempted to measure the force required to rotate the ignition switch from the **ON** to **ACC** position, measured at the same distance from the switch as the car's key handle.

- The **black-shell ignition switch** required, on average, more than **3 in-lbf** of torque to turn.
- The **white-shell ignition switch** required less force than our equipment could detect (below the minimum threshold), and therefore registered as **0**. We are currently working with a specialized calibration lab to obtain more precise measurements

We believe this evidence demonstrates that Hyundai recognized the white-shell ignition switches as a safety hazard, as they were far too easy to turn while the vehicle was in motion. Hyundai identified the softer springs within the detent-switching mechanism as the cause and addressed the problem by installing stiffer springs. To further ensure that old stock could not be mistakenly used in production, Hyundai changed both the shell color and the fitment tab.

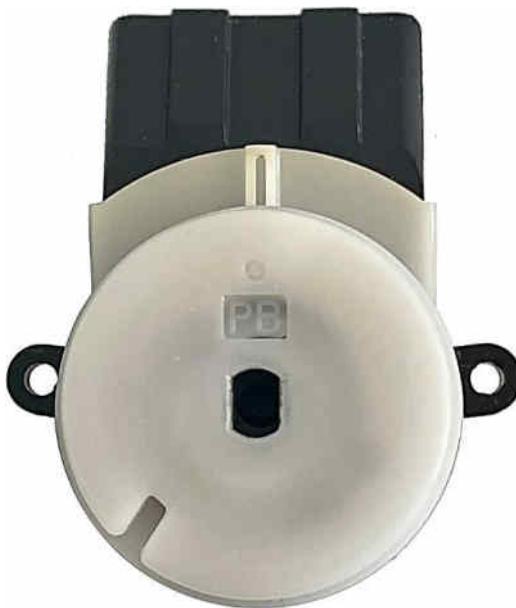
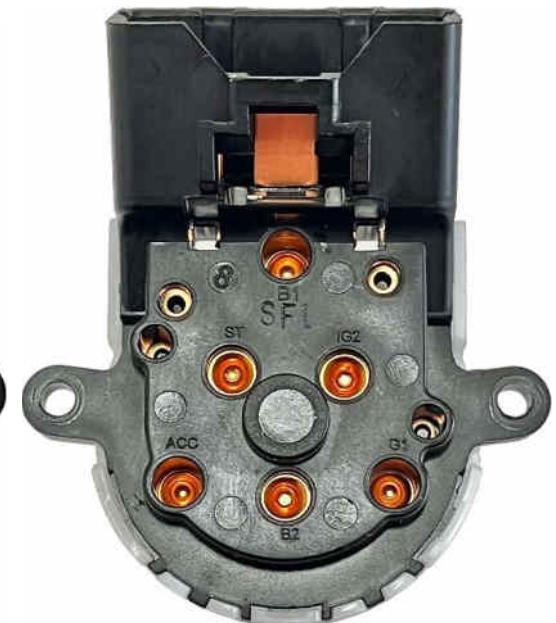
Reference: PB

However, Hyundai did not inform consumers of the risks posed by the white-shell ignition switch in earlier vehicles, nor did it issue a recall to replace the two springs within the ignition switch.

Part #: 93110-3S000

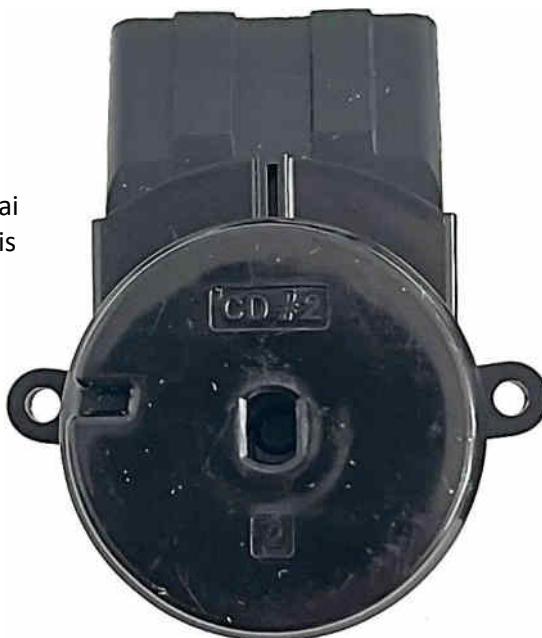
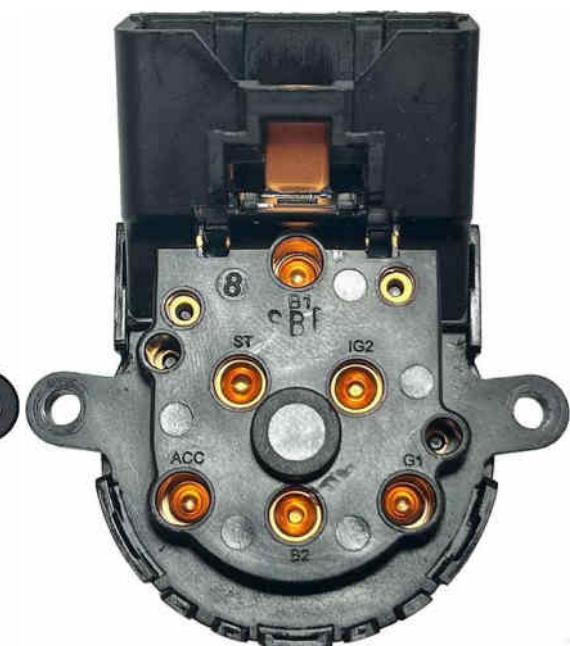
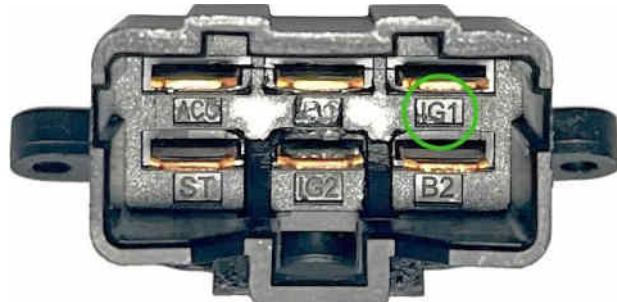
Reference: CD2

Note: We are unable to identify a part number for this switch. Hyundai dealerships have confirmed that this switch is not sold individually.

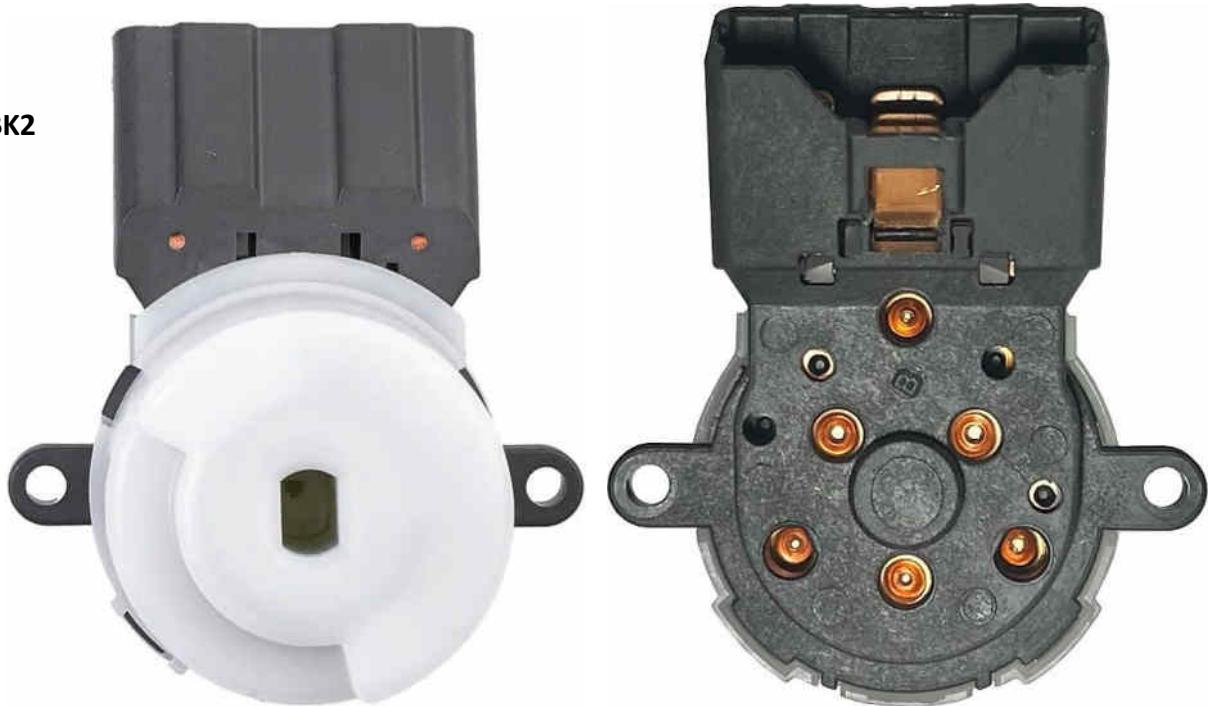
Part #: 93110-1R000
Reference: RBK1 / RBK2

The RBK switch was designed with higher torque ratings than the PB switch and utilized a single, larger spring. Our investigation indicates that the RBK switch was initially produced in 2010 as the RBK1, followed by an updated RBK2 design in 2011.

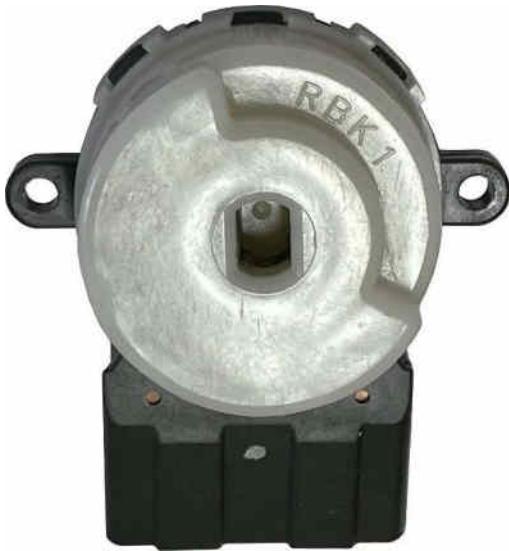
RBK 1

- 1) The switch displays its manufacturer model/reference number on its casing.

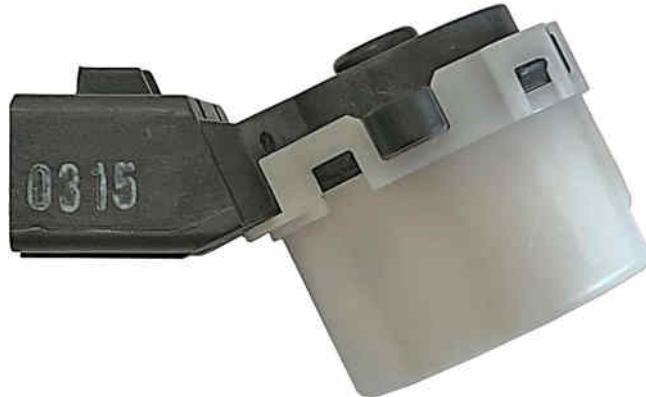
- 2) The switch displays its production date-code prominently printed onto the side of its casing (4 characters).

The date-code utilizes 4 characters.

The first character appears to represent the production year.

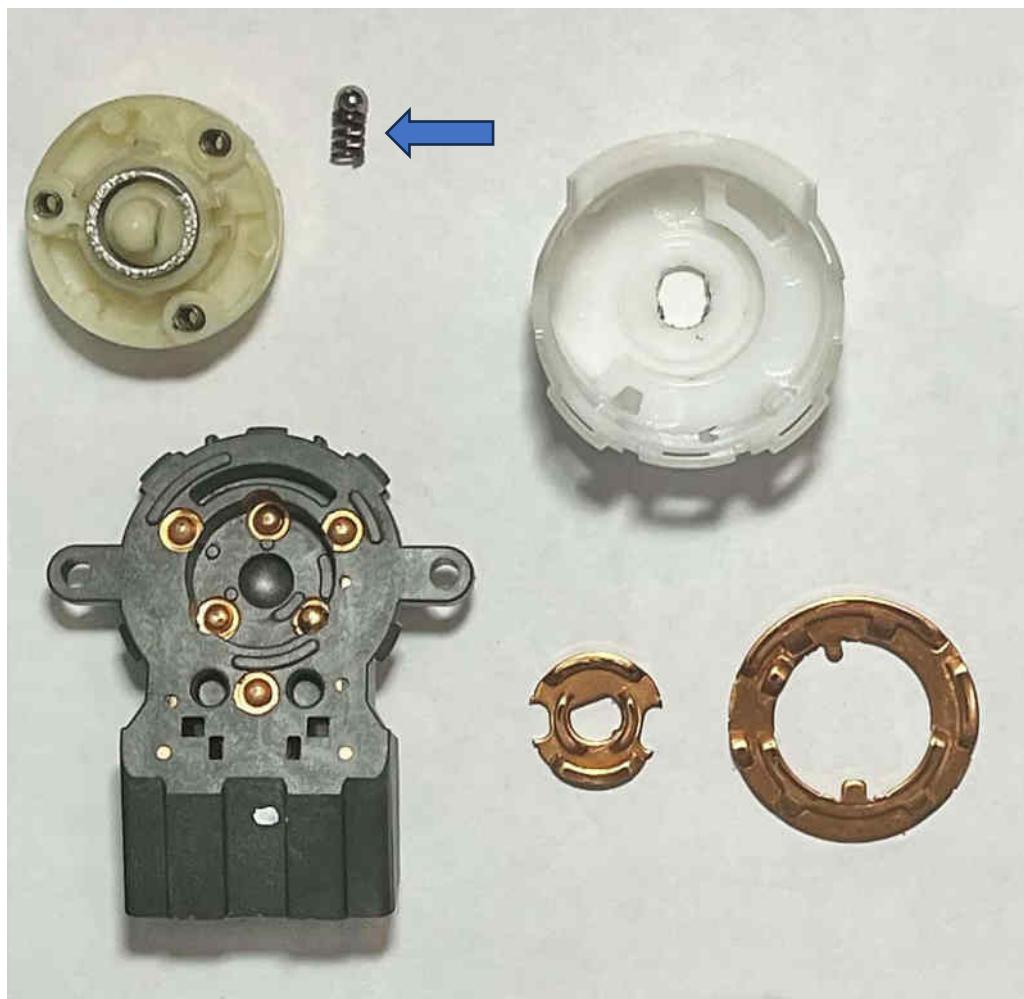
The RBK1 switch uses a single spring paired with a small ball bearing (see blue arrow), which helps secure the switch's position within the case detents.

The force required to compress the spring sufficiently to allow the ball bearing to move between detents provides the turning resistance, or "torque force," that helps prevent the ignition key from turning inadvertently (e.g., from ON to ACC).

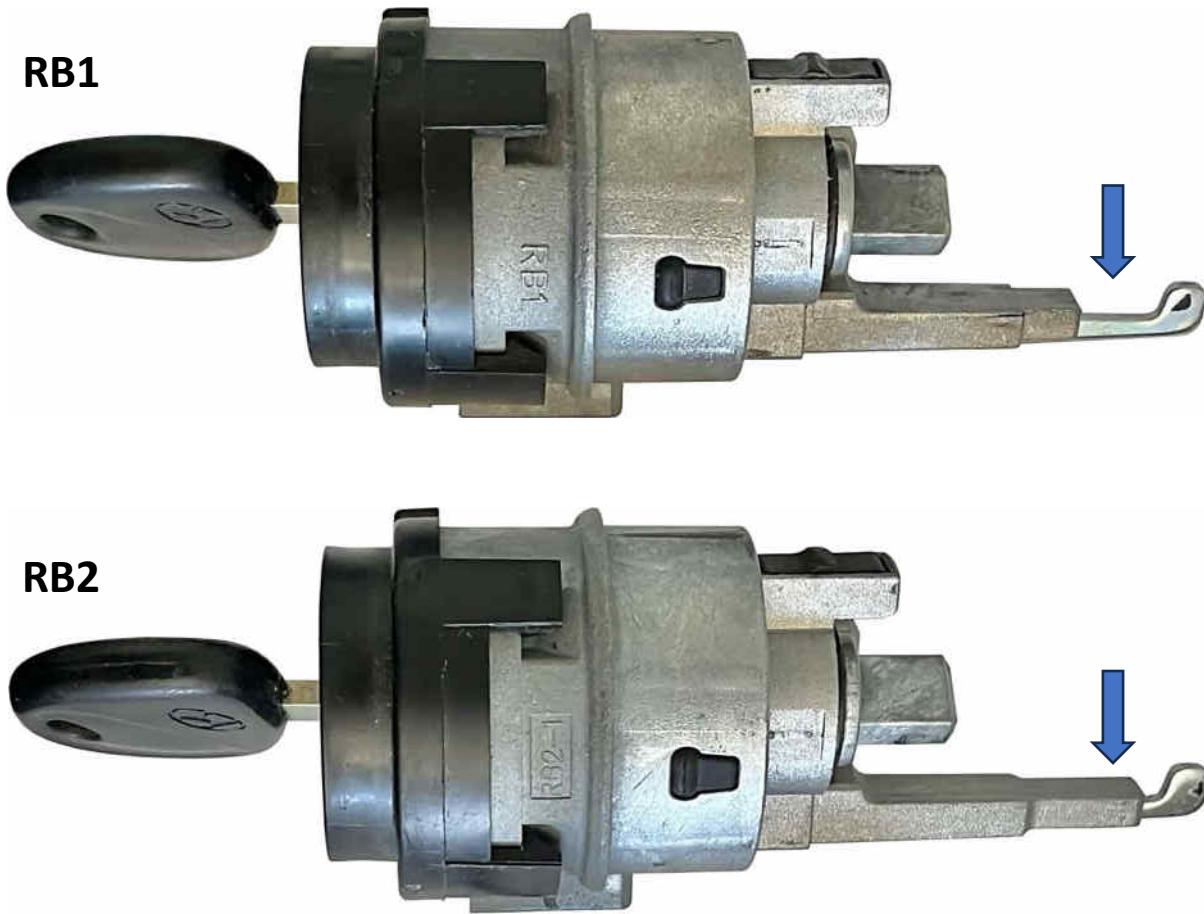
The 2012 Accent was introduced with the RB1 ignition cylinder. Shortly thereafter, Hyundai introduced the RB2 ignition cylinder, which made modification to the lever latch's railing and extended it.

Once this change is noted, it is apparent that "RB" refers to the ignition cylinder's model, and the numbers (i.e., "1" or "2") refer to the model revision.

It is interesting to note, that the lever latch is a safety mechanism that is designed to prevent steering-wheel lock ups while the key is still inserted. It could be hypothesized that Hyundai may have become concerned that 2012 vehicles could lose steering control and sought to make changes to both the ignition cylinder's lever latch and the ignition switch (in order to rule out multiple sources for such a malfunction).

The 2012 model was the first Accent to use a plastic ignition assembly. The plastic ignition assemblies had more tolerance or flex within its components, which made it more likely for the lever latch safety mechanism to fail to prevent an inadvertent deployment of the steering lock. Extending the lever latch rail would have reduced the amount of play within the lever latch and helped improve the safety mechanism's effectiveness.

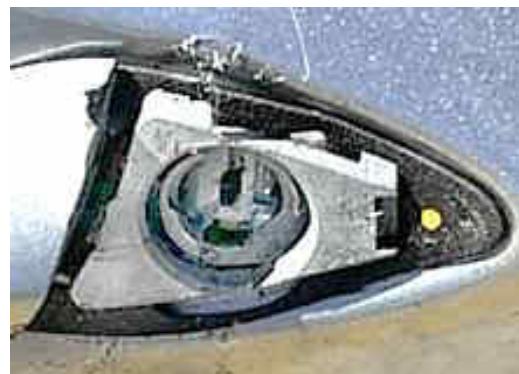
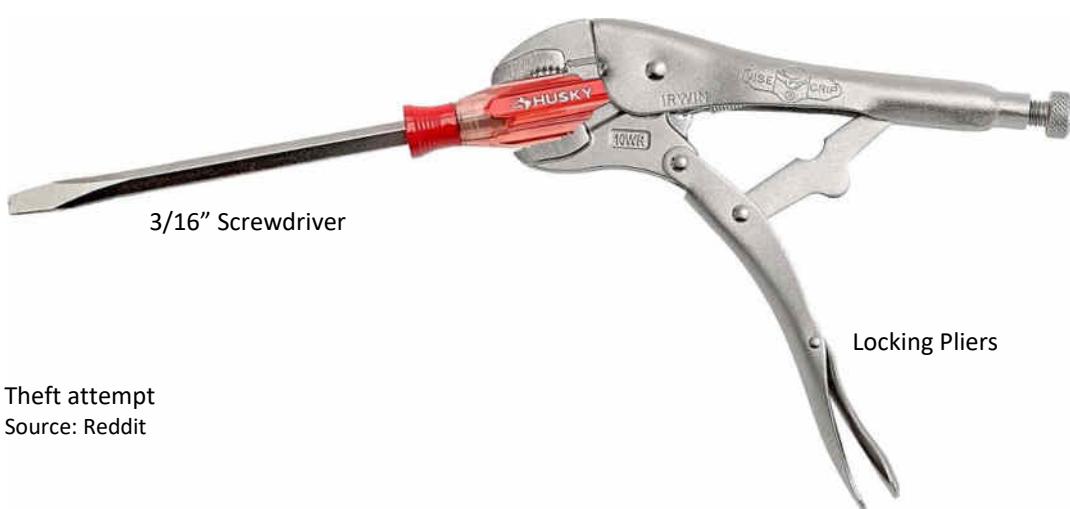
The most common method for bypassing the “Anti-Theft Logic” alarm today involves using brute force on the door lock cylinder. This technique predates the anti-theft update and is preferred because it avoids breaking windows. Tutorial videos demonstrating this method can be found on social media under usernames or tags such as “KiaBoyz.”

Typically, thieves use a screwdriver and locking pliers (“vice grips”) to forcibly turn the lock cylinder. The cylinder’s pins either shear or carve into the soft pot-metal, allowing the lock to turn. In many cases, the weak material causes the cylinder to crumble or be pried out entirely.

Once the cylinder turns, the door unlocks without triggering the alarm, allowing the thief to remove the ignition cylinder and start the car.

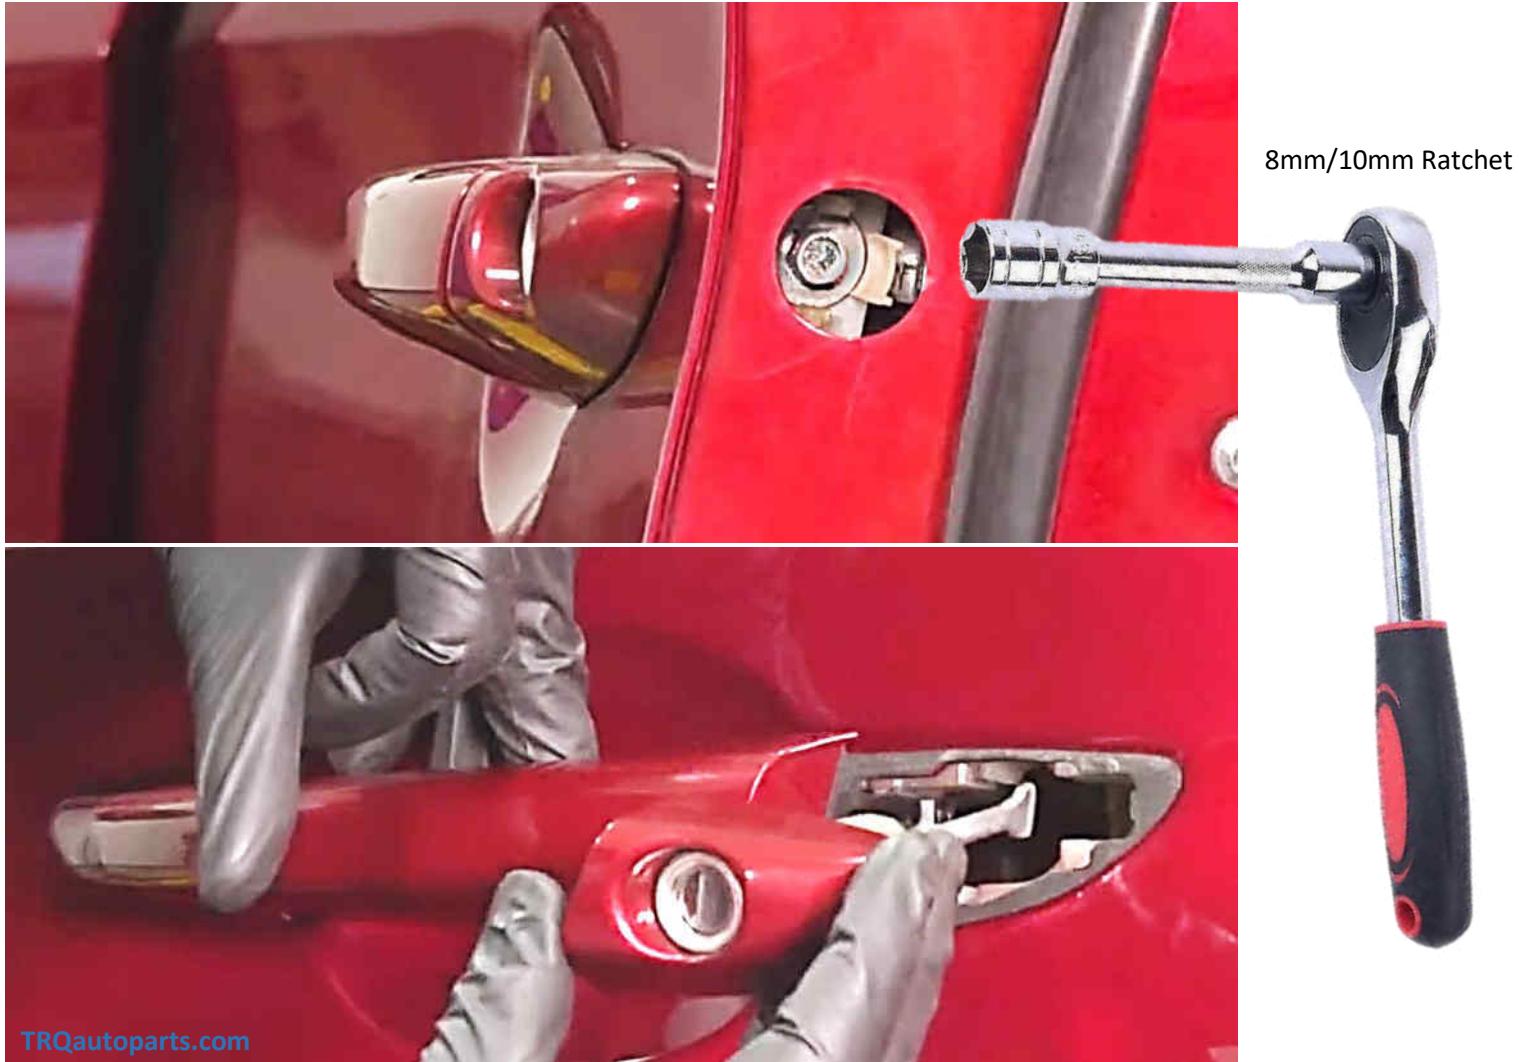
Although brute-force attacks on the door lock have proven effective—and improvements in material and construction are clearly needed—the mechanical security has occasionally thwarted theft attempts. Unfortunately, oversight in the lock's design allows even arthritic seniors to disable the alarm in under a minute.

If a thief cannot turn the lock cylinder directly, they can break the window, unbolt the door lock, and then use a screwdriver to turn the door actuator. Hyundai and Kia door locks are secured with a standard 8 mm or 10 mm bolt across nearly the entire lineup. Turning the door actuator operates the lock in the same manner as the cylinder, unlocking the car and disengaging the “Anti-Theft Logic” protection.

AutoSafe's security evaluation proposes issuing a recall to change these standard bolts with security / shear bolts.

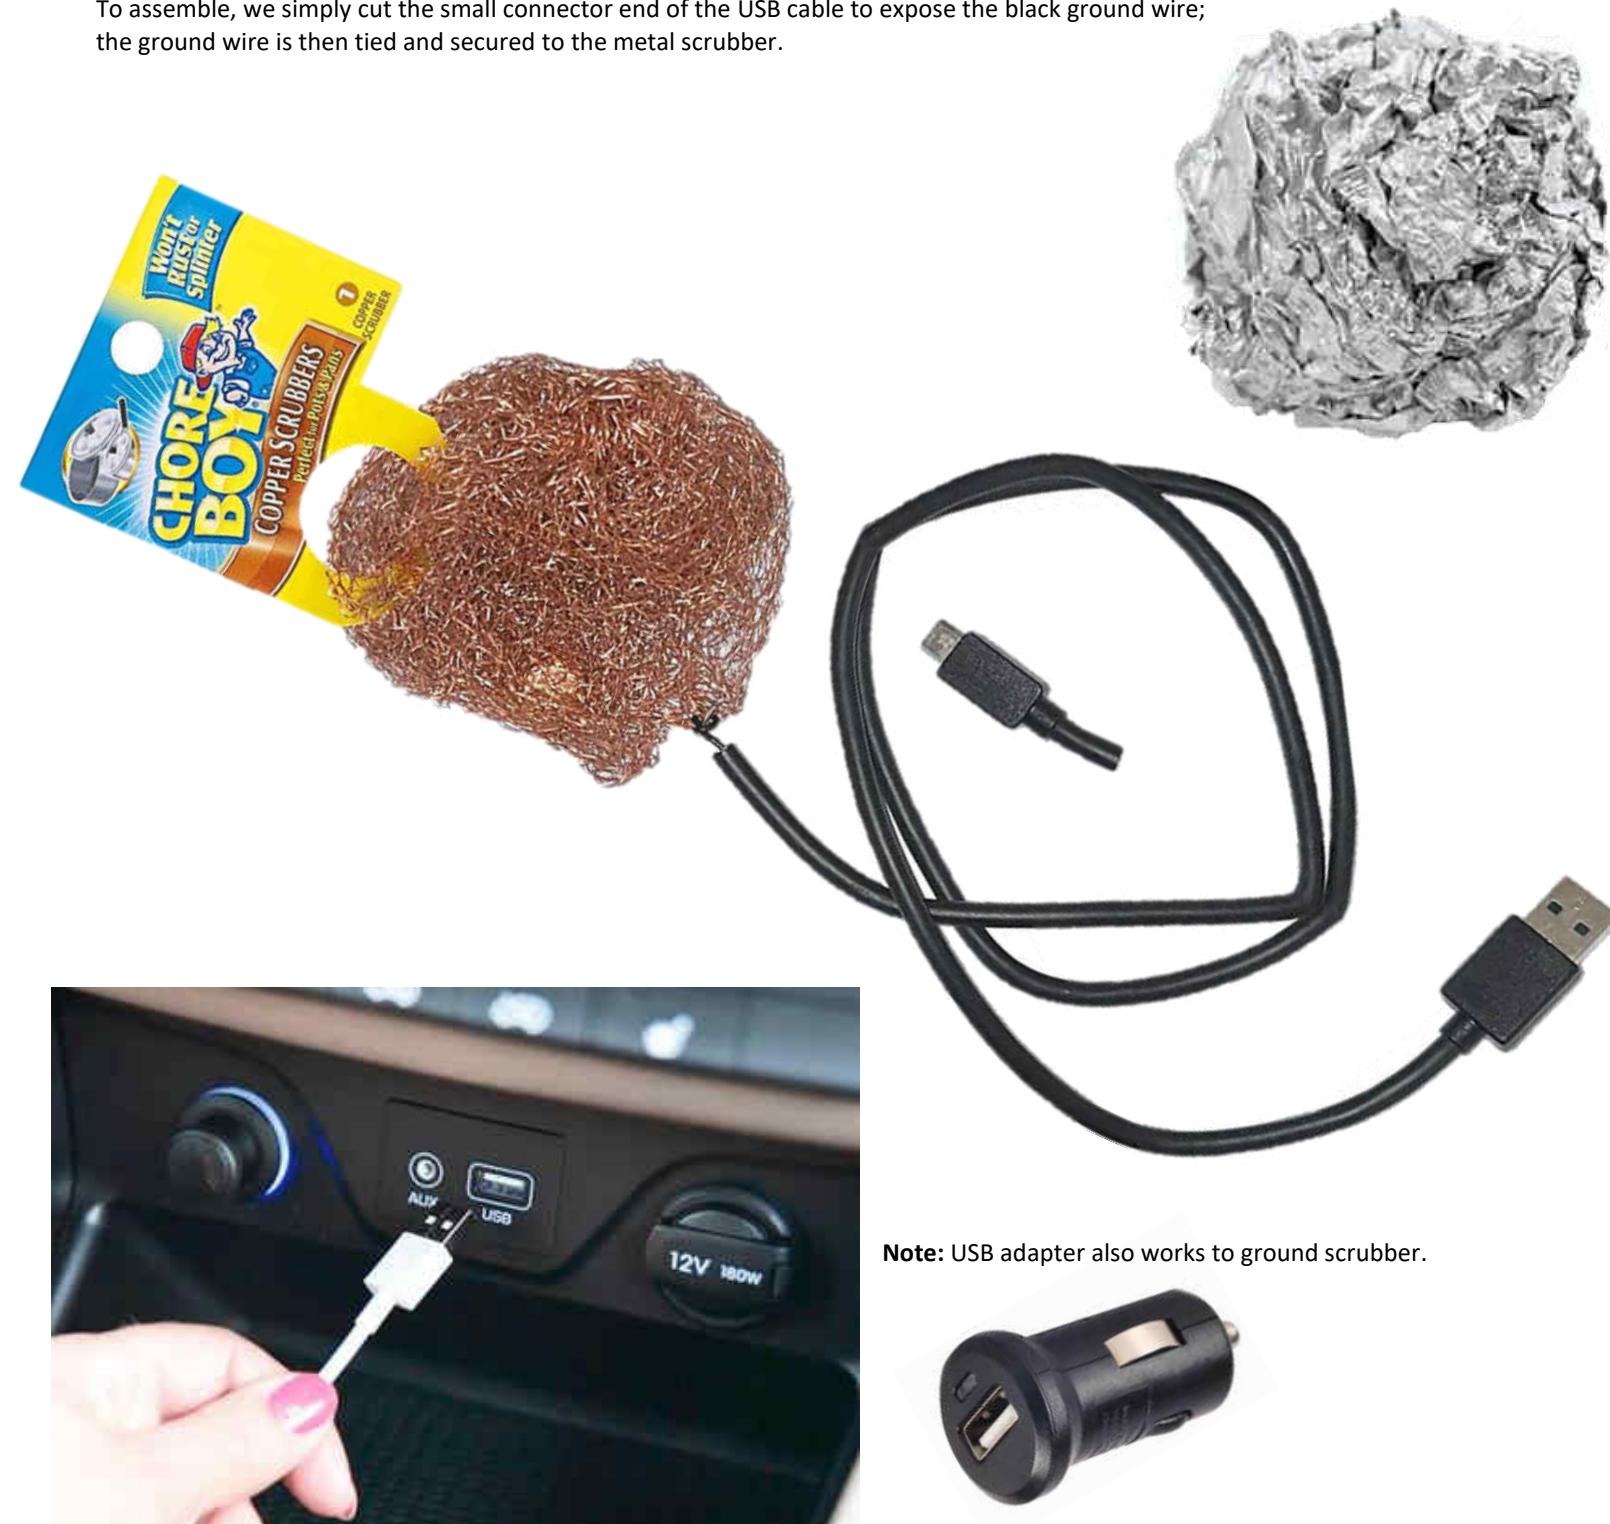
A third method for bypassing the Anti-Theft Logic highlights Hyundai's flawed wiring scheme. The door lock signal pins are held high by default and pulled low when the door is unlocked. This design allows someone to mass-short the connector pins and disable the alarm.

This can be demonstrated by pressing a ball of tinfoil into the door's wiring harness connector port, which shorts the pins and pulls them low, disabling the Anti-Theft Logic. Because this method can damage electrical components, we instead used a metal dishwashing scrubber (e.g., Scotch-Brite, Chore Boy) to short the pins to the car's USB port. Using this "USB-scrubber" method, we achieved near-instantaneous alarm deactivation on multiple Hyundai and Kia vehicles and presume it is universally effective on all models using the Anti-Theft Logic system.

To assemble, we simply cut the small connector end of the USB cable to expose the black ground wire; the ground wire is then tied and secured to the metal scrubber.

Note: USB adapter also works to ground scrubber.

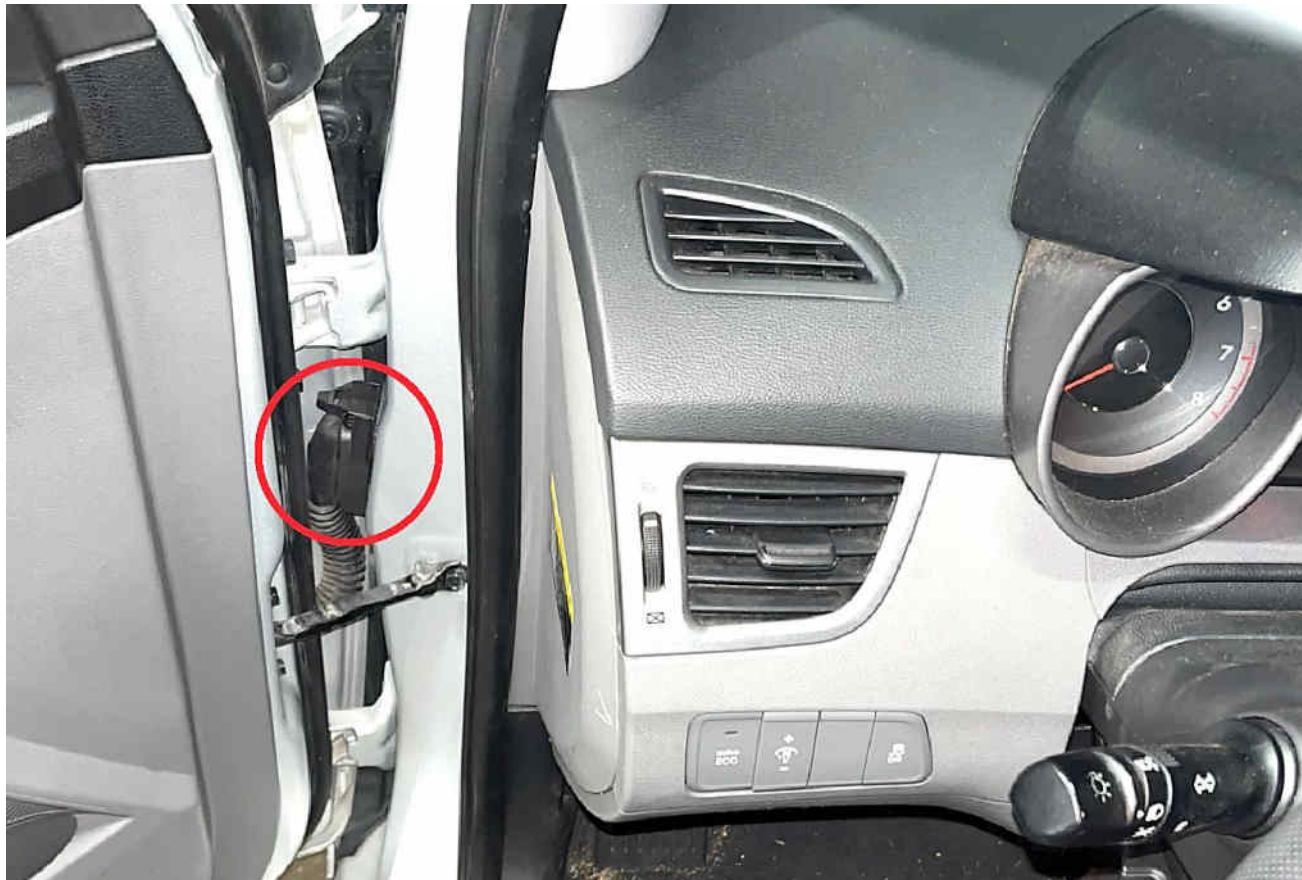
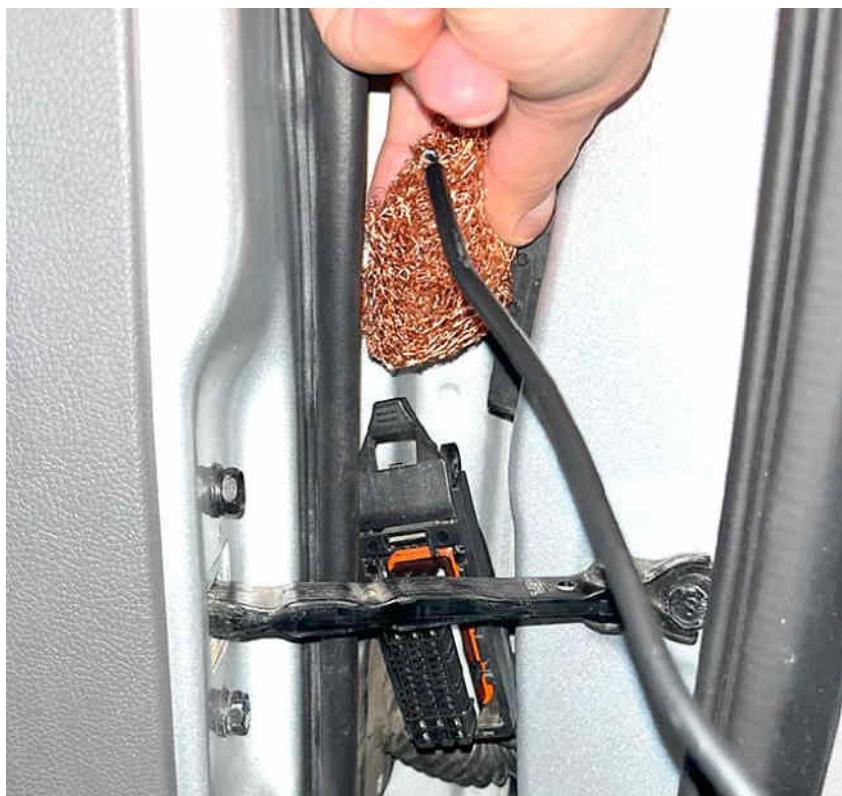
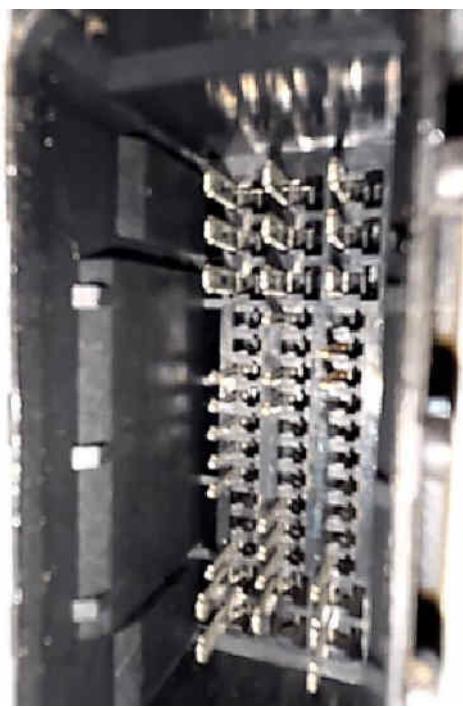
Inside door connector port

The ball of tinfoil or metal scrubber is inserted into the driver door connector port to make contact with the pins within. The active alarm should silence and the “Anti-Theft Logic” should now be disabled.

AutoSafe’s security evaluation proposes changes to the wiring scheme to prevent the mass shorting of pins disabling the alarm.

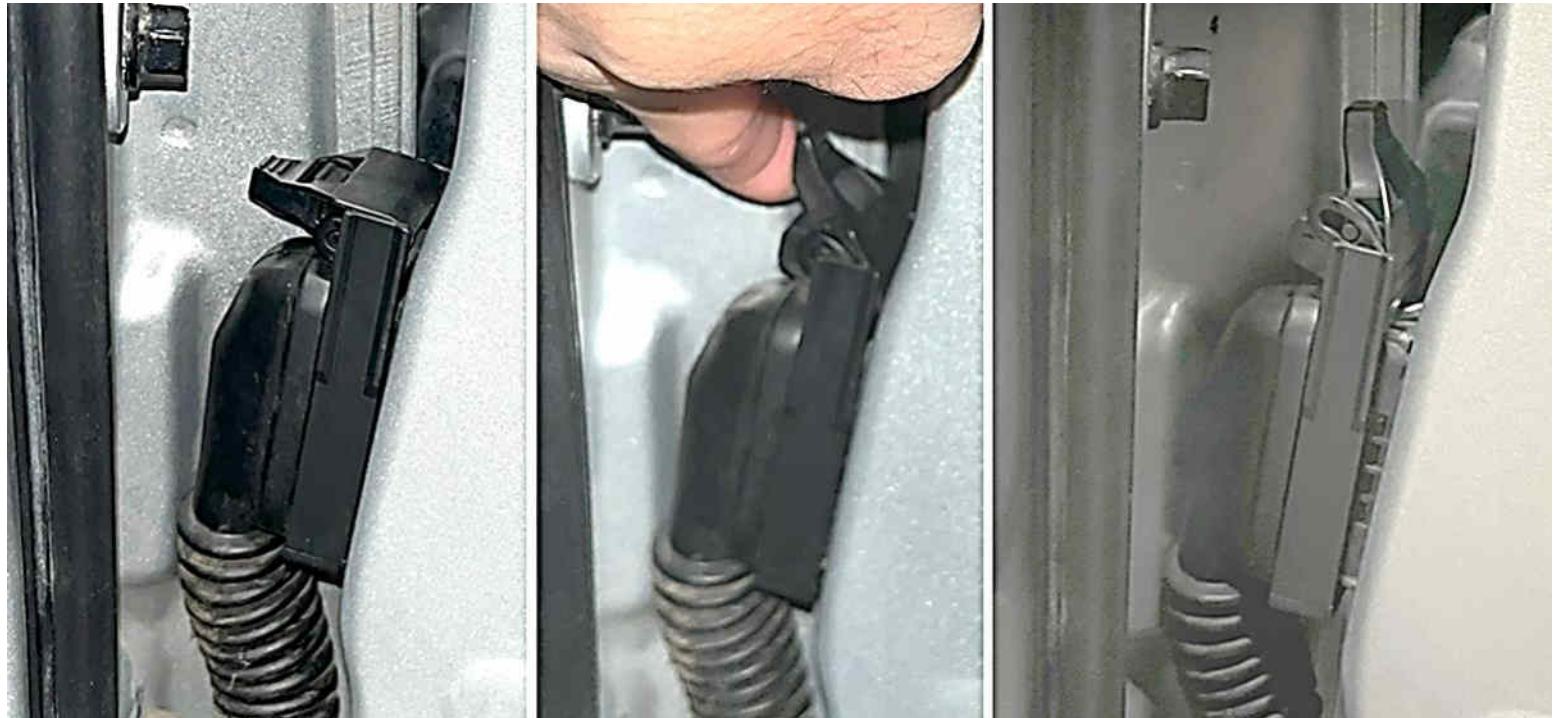
Type 1 Connector (Soda Tab):

Using finger, lift tab up like a soda can tab. Continue to push tab towards door frame until connector partially pops out.

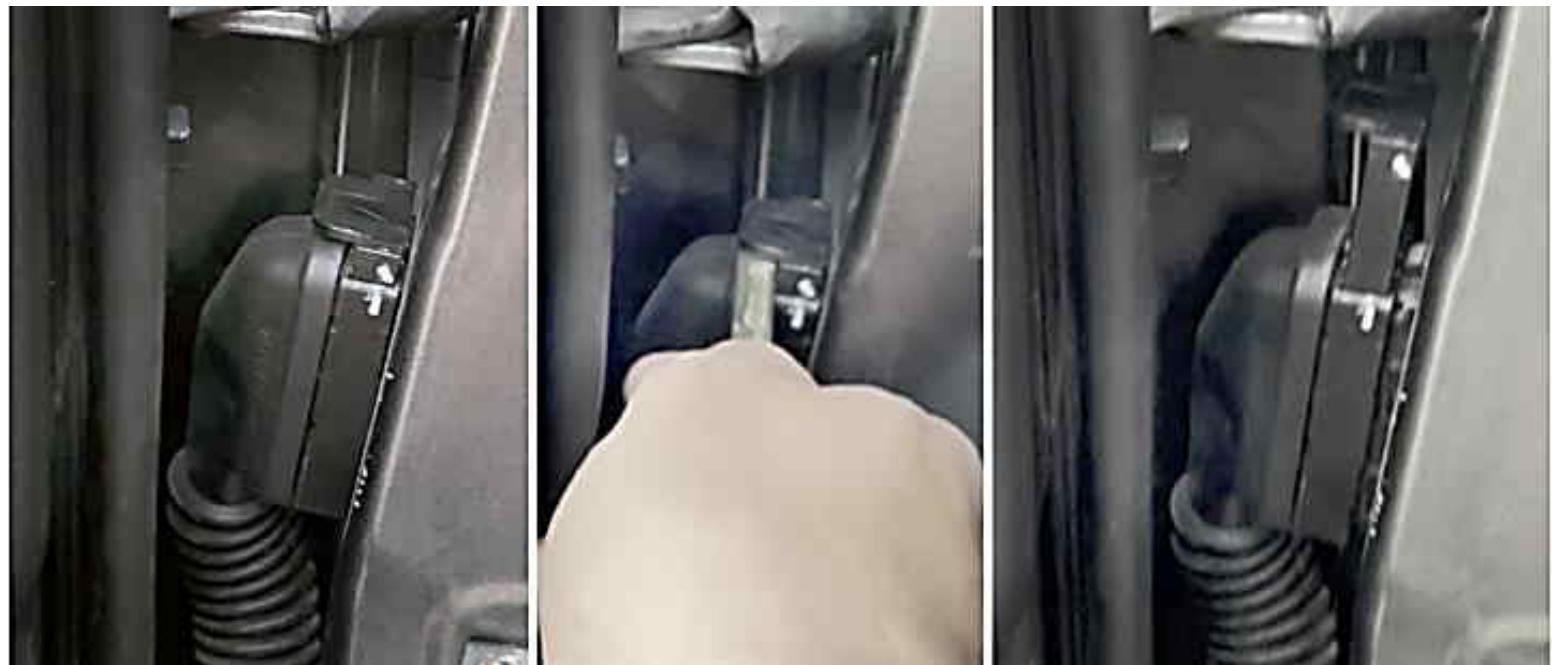
Type 2 Connector (Lift Tab):

Place a key under the tab and lift straight up. Continue lifting the tab until connector partially pops out.
