Flawed Logic: The Hyundai Anti-Theft Campaign

An analysis of the campaigns to address rampant theft
of Hyundai and Kia vehicles across America

FULL REPORT – DEFECTS & ANTI-THEFT CLAIMS

Rev. 1/22/2026

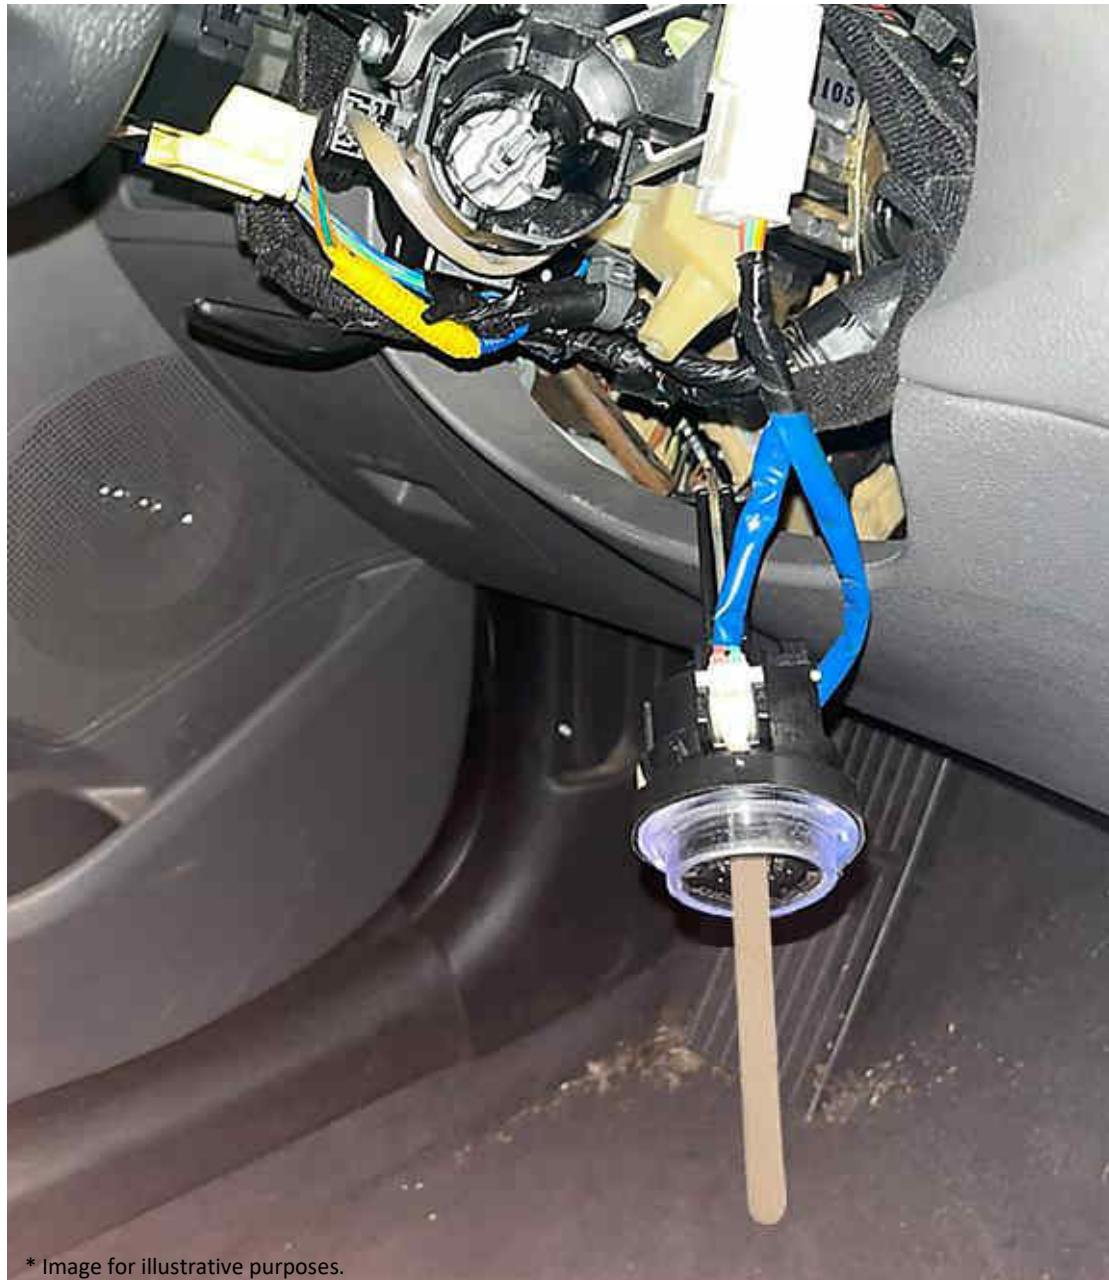
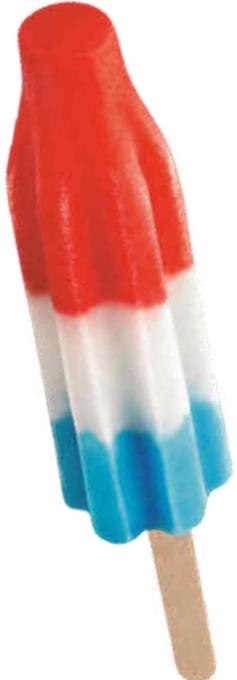
Our testing shows this supposed immobilizer upgrade is largely ineffective. The ignition cylinder only uses a simple switch to signal the insertion of an object—presumably a key. It cannot verify whether the object is a genuine Hyundai/Kia key or even a key at all.

Defeating this “requirement” was trivial and a popsicle stick proved ideal at simulating a Hyundai-Kia key, fitting all Hyundai-Kia cylinders tested. It was found that the popsicle stick only needed to be firmly inserted about 1/2” to actuate the switch before turning the tumbler rod to start the ignition.

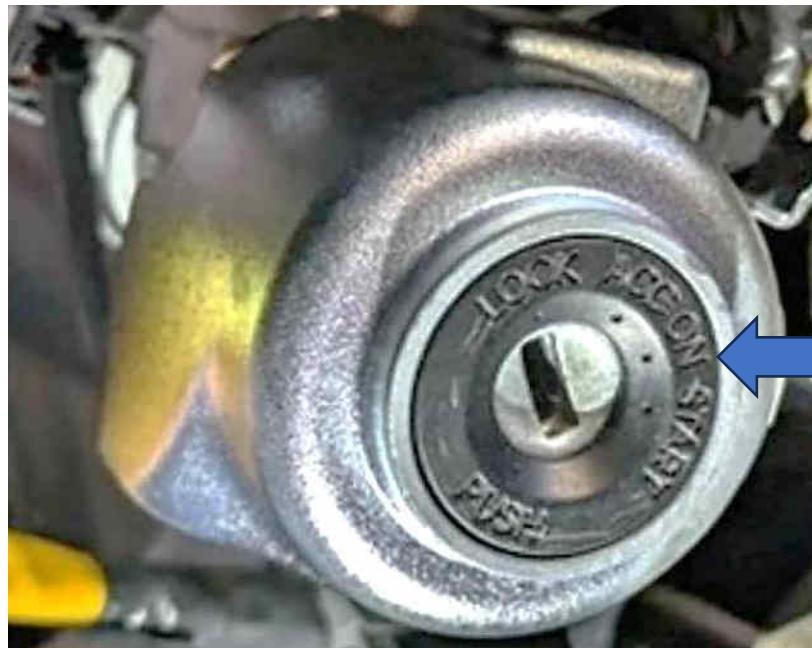
The plastic face of the cylinder has been left exposed, without any metal shielding. This leaves the cylinder's internal components completely exposed, and able to be pried out.

The plastic cover of the cylinder has been left uncovered and unprotected.

The uncovered plastic face of the cylinder can still be easily broken off and allow the internal components of the cylinder to be pried out and turned with a flathead screwdriver, which is made even easier with the use of vice grips or locking pliers.

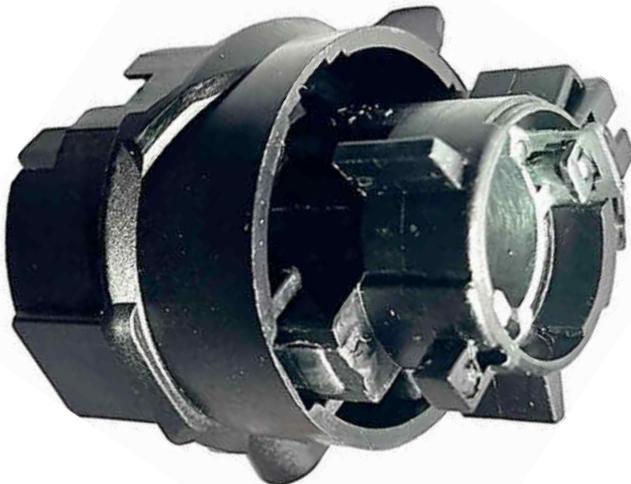
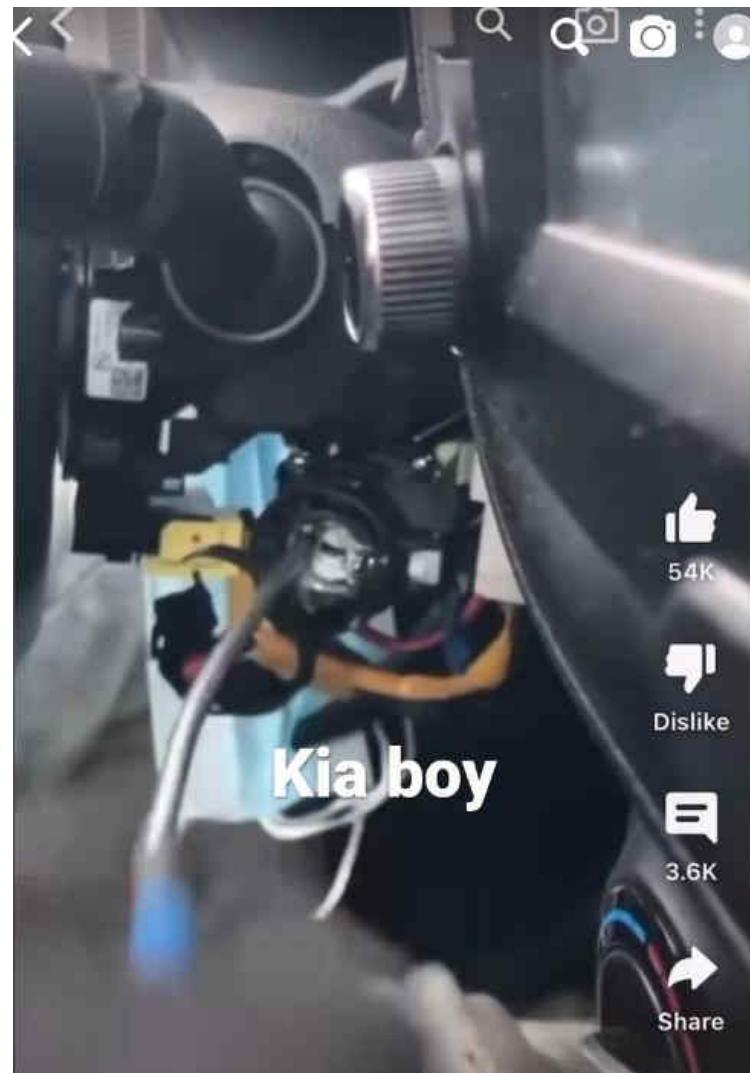
Example 2011+ ignition cylinder (plastic construction)

Unfortunately, the metal sleeve does not even attempt to prevent prying of the cylinder's internal plastic components.

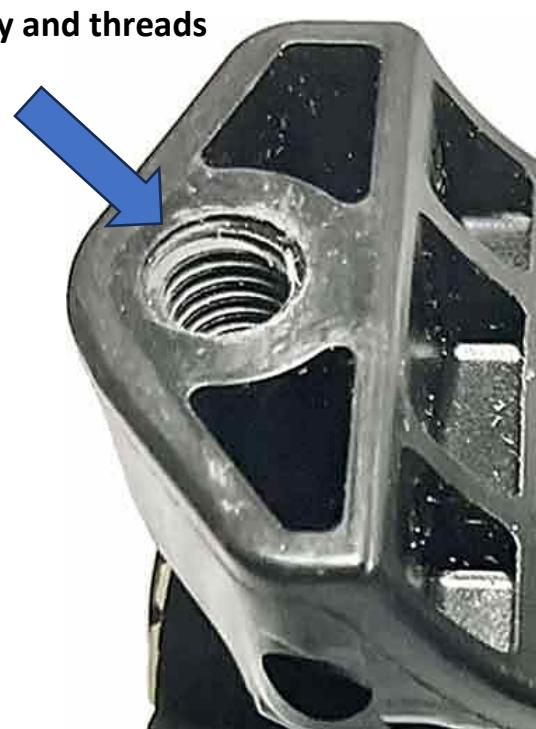
Plastic body and threads

Another issue that the cylinder sleeve fails to address is that the assembly is secured to the steering column by metal bolts, which are held in by the assembly's plastic body and threads.

If the bolts are heated and then removed, the ignition assembly can be pushed down about 1-inch to free the steering lock and allow free movement of the steering wheel (after the car turns on).

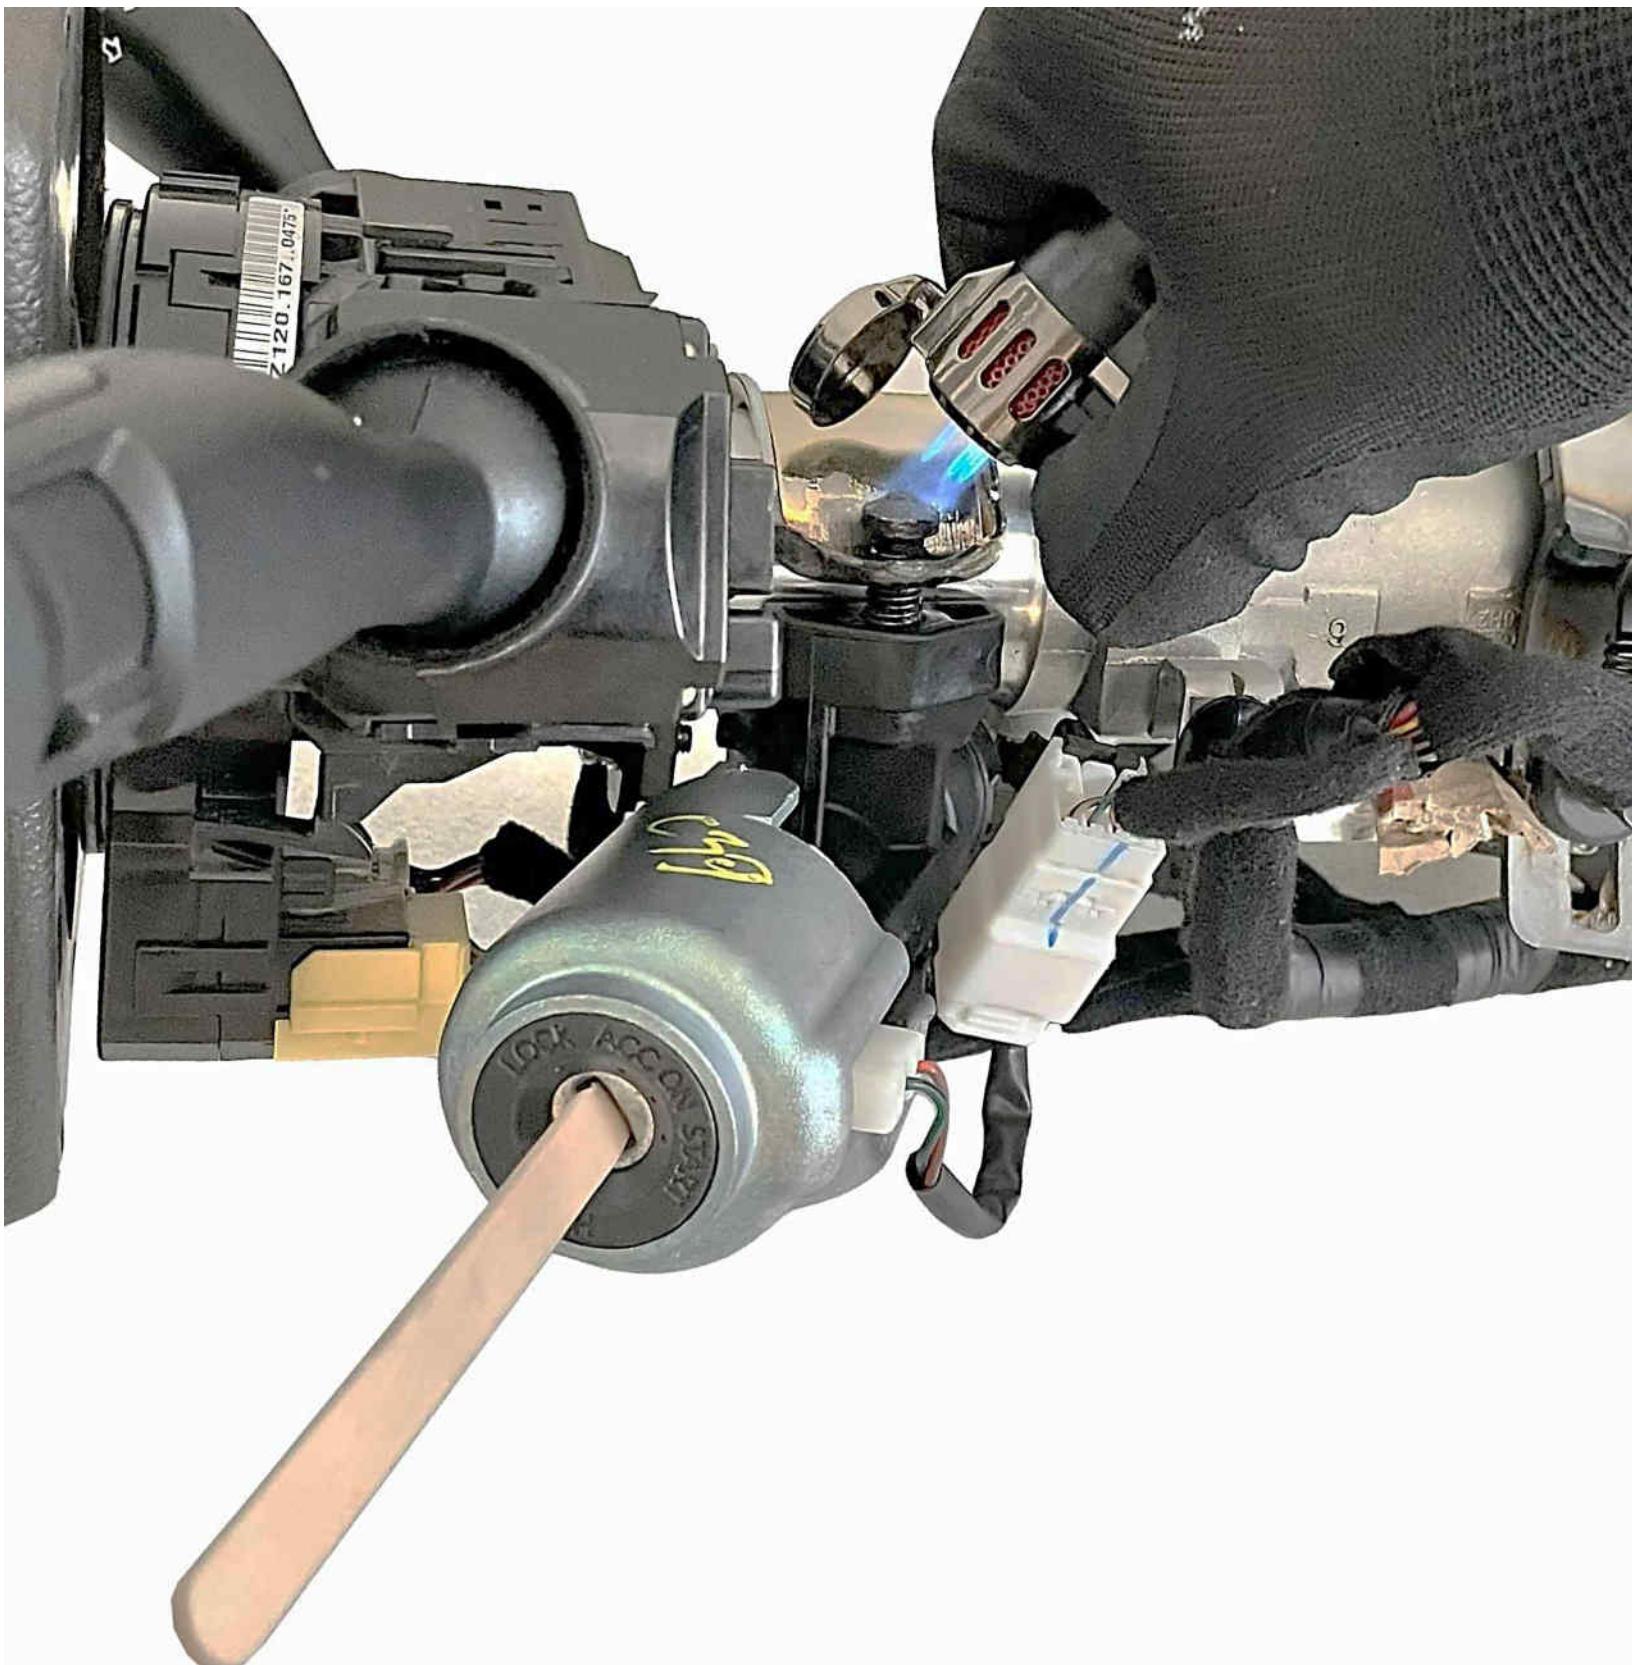
Step 3: Insert a popsicle stick into the ignition (only required for vehicles also upgraded with software update).

Step 4: Insert paperclips into the ignition switch's connector to start the car.

Although the metal protector partially patches the ignition assembly's cylinder, it still leaves the rest of the plastic assembly completely vulnerable; therefore, the lighter bypass demonstrated exploits the assembly's fundamental weakness (and the same defect)—the ignition housing's plastic construction.

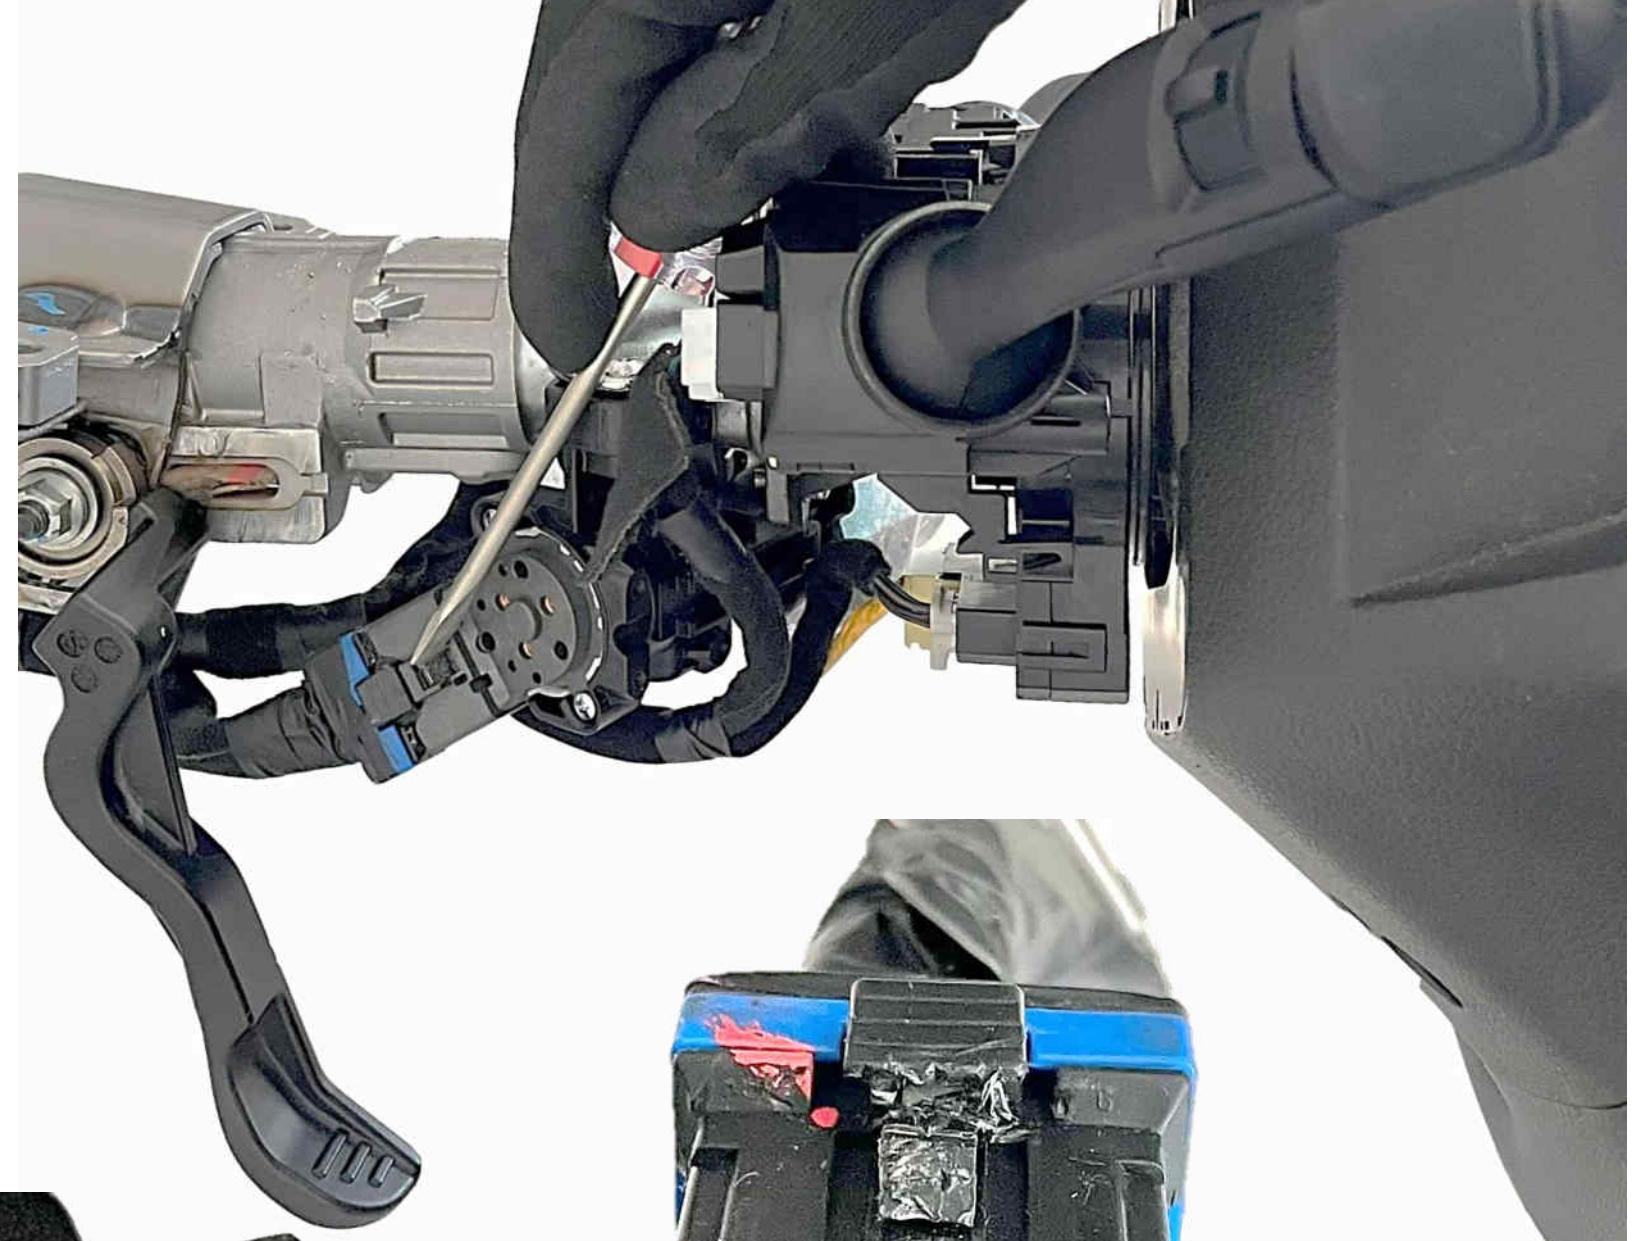
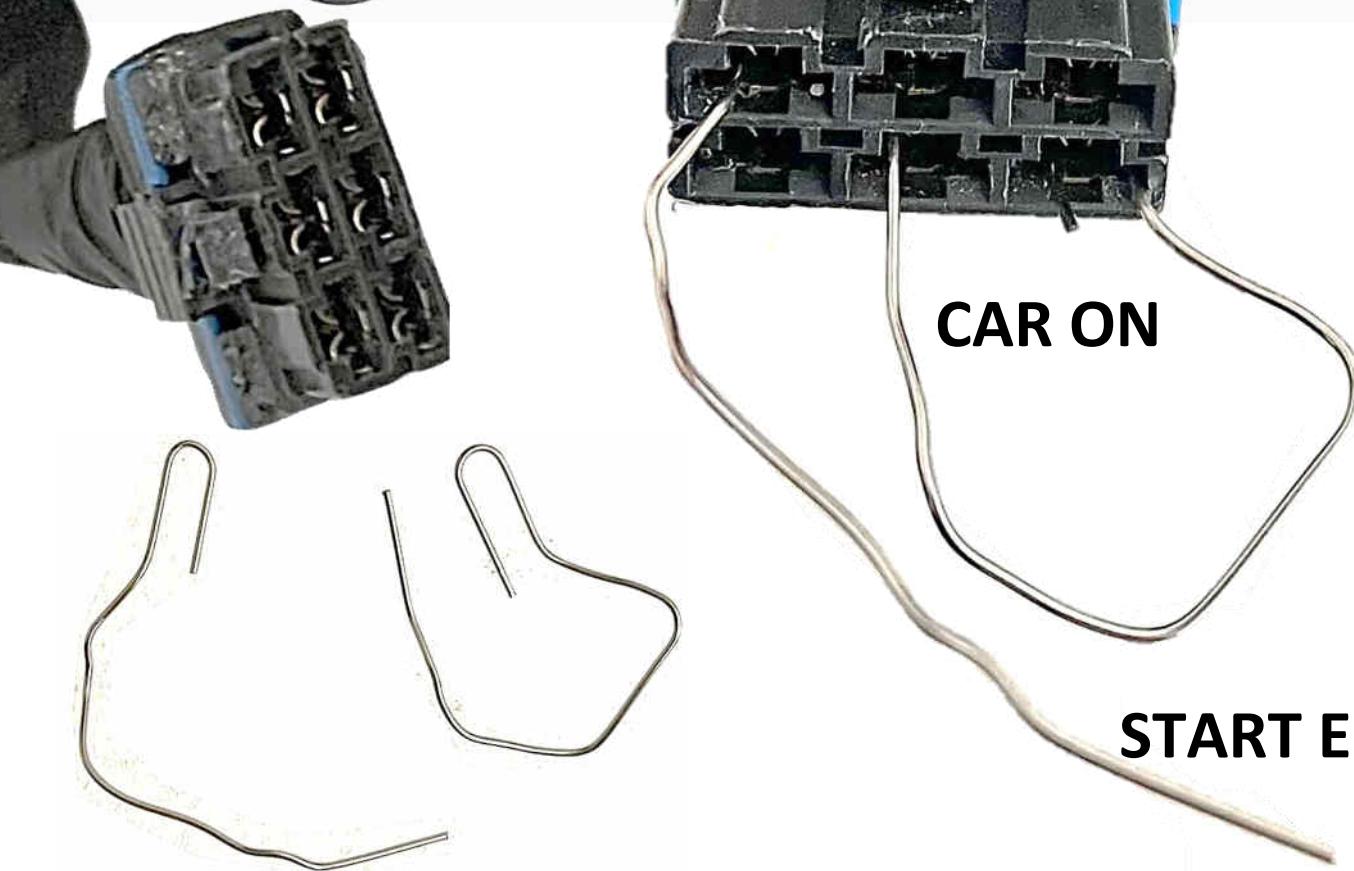
By heating the bolts and extracting them from the plastic housing, the ignition assembly's steering lock can be disabled by simply pushing down on the assembly. The steering wheel will then be able to turn freely once the car is turned on.

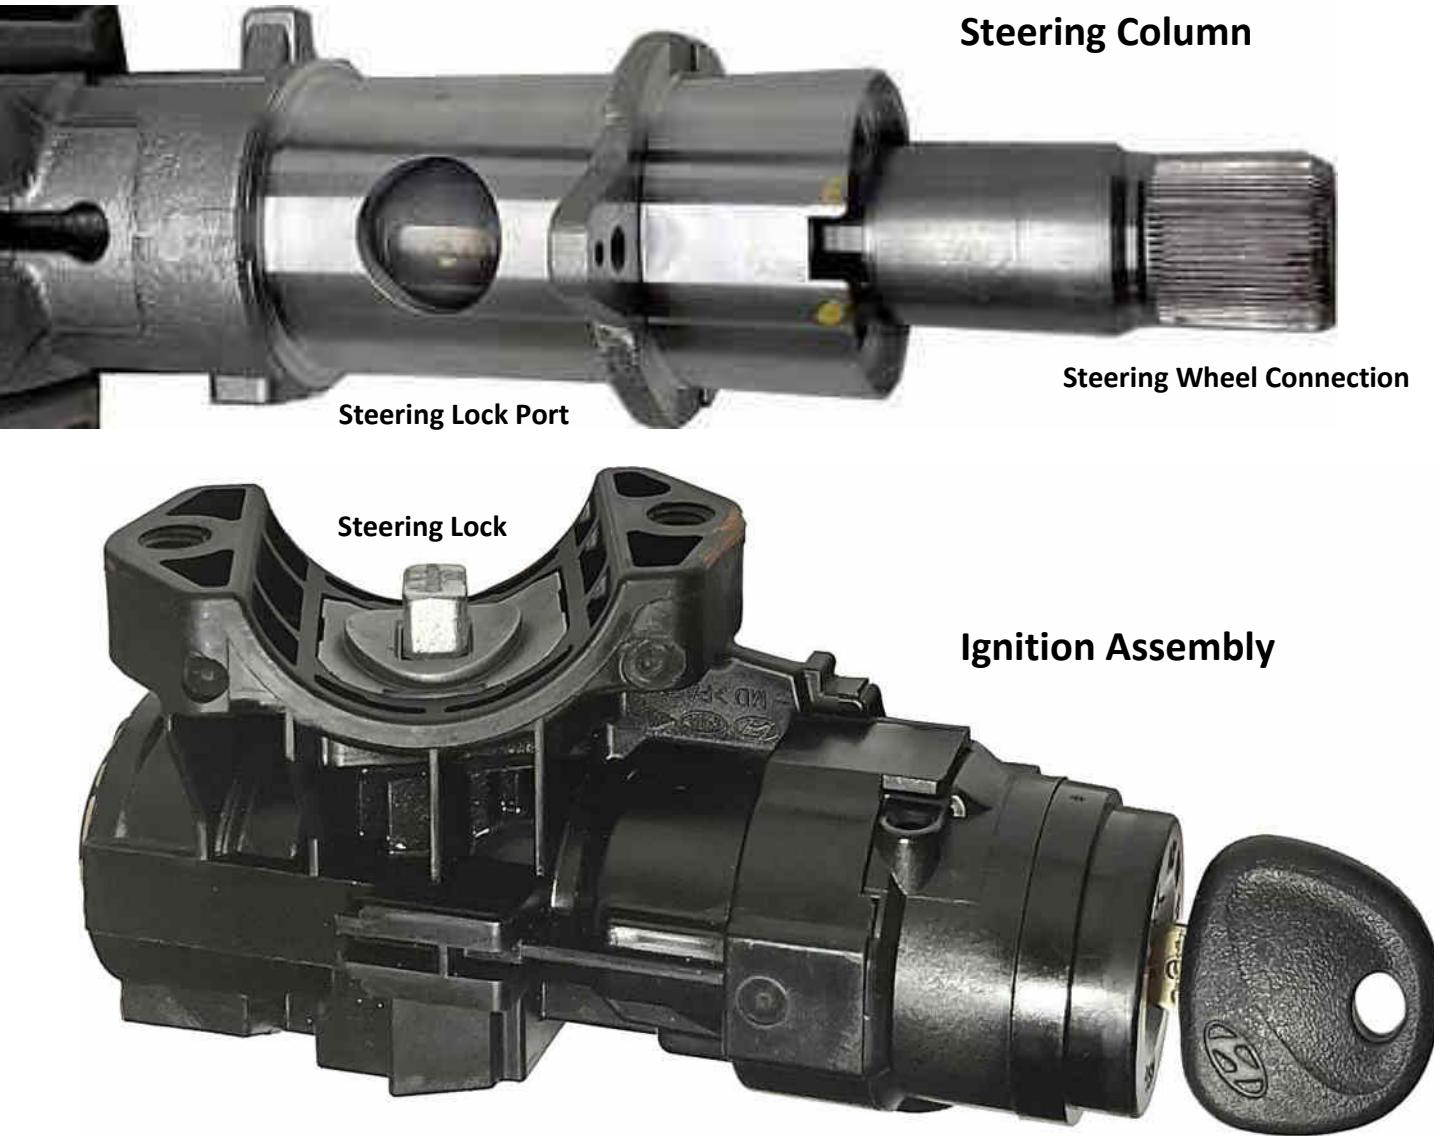
The purpose of the metal protector is to reinforce the cylinder because it is made of plastic. Hyundai even spent a considerable sum to [claim](#) their ignition cylinder sleeve has been independently tested and verified by a leading engineering and scientific consulting firm; however, it was disappointing to see that the cylinder "protector" had such a glaring design flaw that left the front plastic cover completely unprotected. Hyundai should expect that thieves will utilize the same prying and brute force methods currently used to bypass the door lock on the ignition cylinder.
